# City of Beverly Hills Historic Resources Survey Report

## *Survey Area 5: Commercial Properties*

Part I: Historic Resources Survey Update

Part II: Area 5: Commercial Property Survey

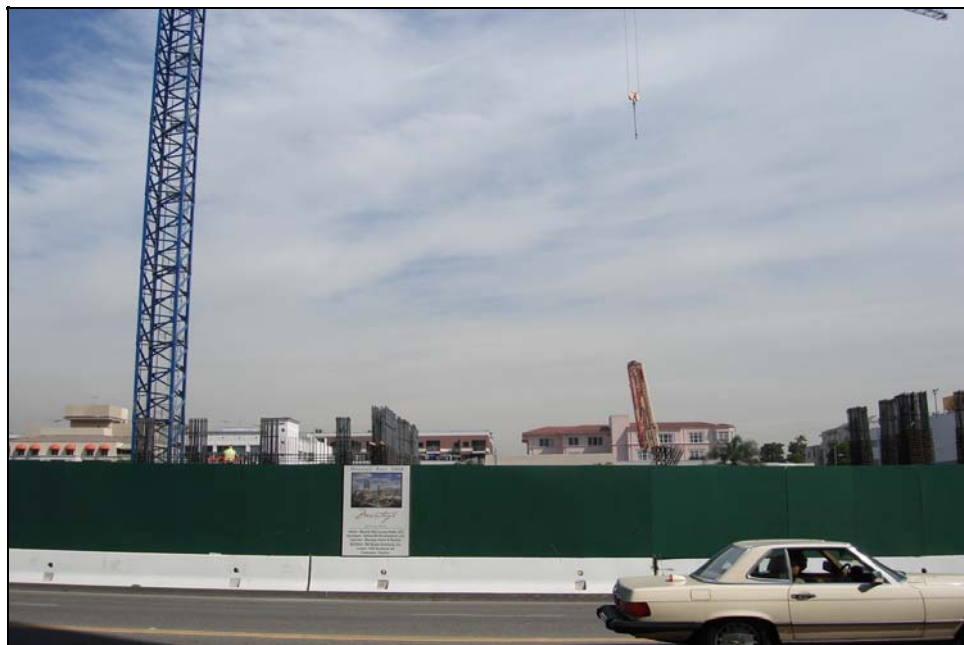
*The Beverly Theater was demolished since it was last evaluated in the 2004 survey. Originally evaluated in the 1985-1986 survey as significant as a Moorish Revival style building with Modern architectural elements, it no longer would be eligible for local listing or designation. As a result, the previous CHR status code of 5S3 is changed to 6Z.*

**P5b Description/Date of Photo:** Post demolition, March 7, 2007.

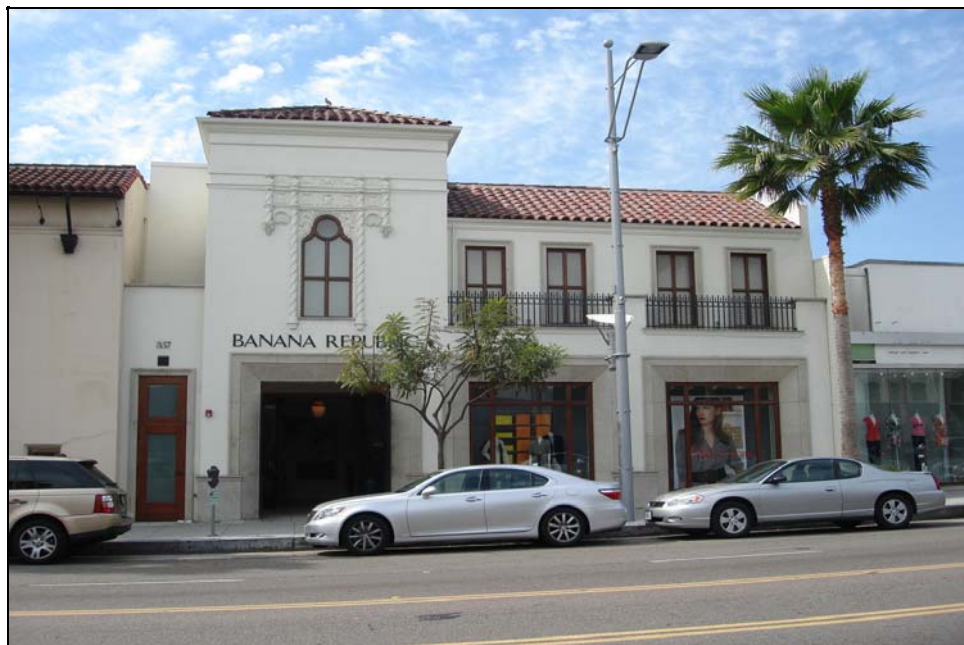
*Between the 1985-1986 and 2004 survey evaluations, the storefront windows were altered. The window openings, glazing, and surrounds were replaced. However, the window modifications have not compromised the overall Spanish Colonial Revival architectural style of the commercial building. Therefore, the building, which is in good condition, remains individually eligible for local listing or designation. There have been no major modifications since the 2004 evaluation.*

P5b Description/Date of Photo: East elevation, looking west/ March 7, 2007.

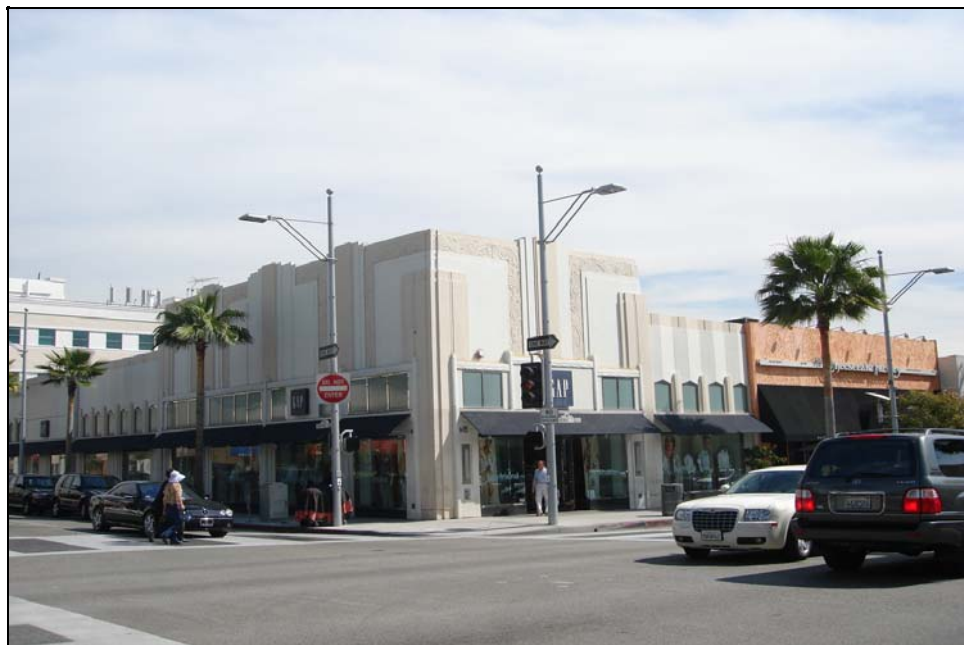
*This building appears in good condition with no significant alterations visible since the property was evaluated in the 1985-1986 survey and re-evaluated in the 2004 survey. It remains eligible for listing in the National Register, the California Register, and for local listing or designation.*

**P5b Description/Date of Photo:** *West elevation, looking east/March 7, 2007*

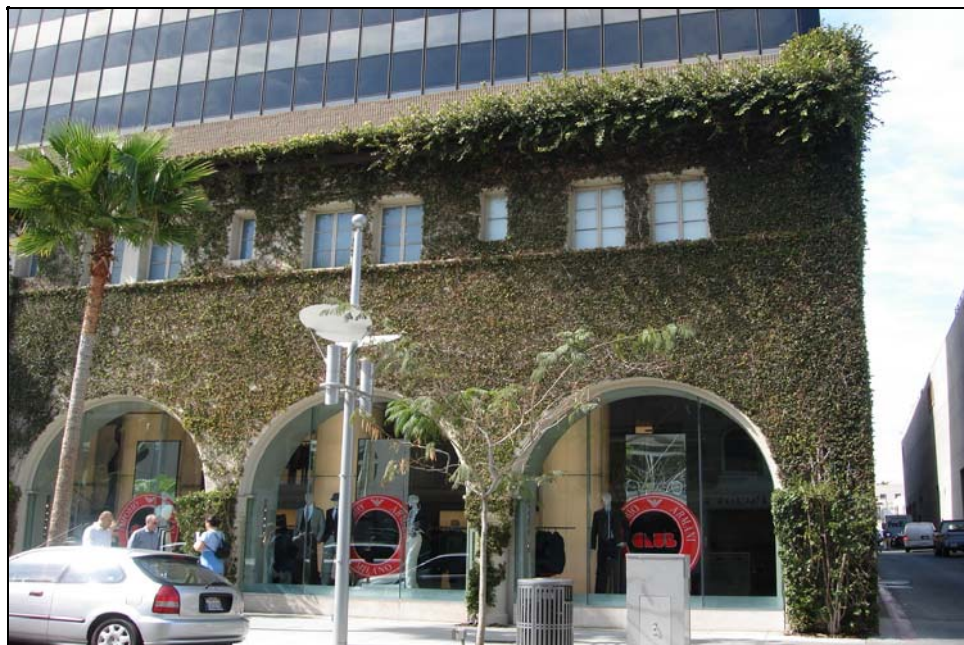
*This building appears in good condition with no significant alterations visible since the property was evaluated in the 1985-1986 survey and re-evaluated in the 2004 survey. It remains eligible for National Register, California Register, and local listing or designation.*

P5b Description/Date of Photo: West and south elevations, looking northeast/March 7, 2007

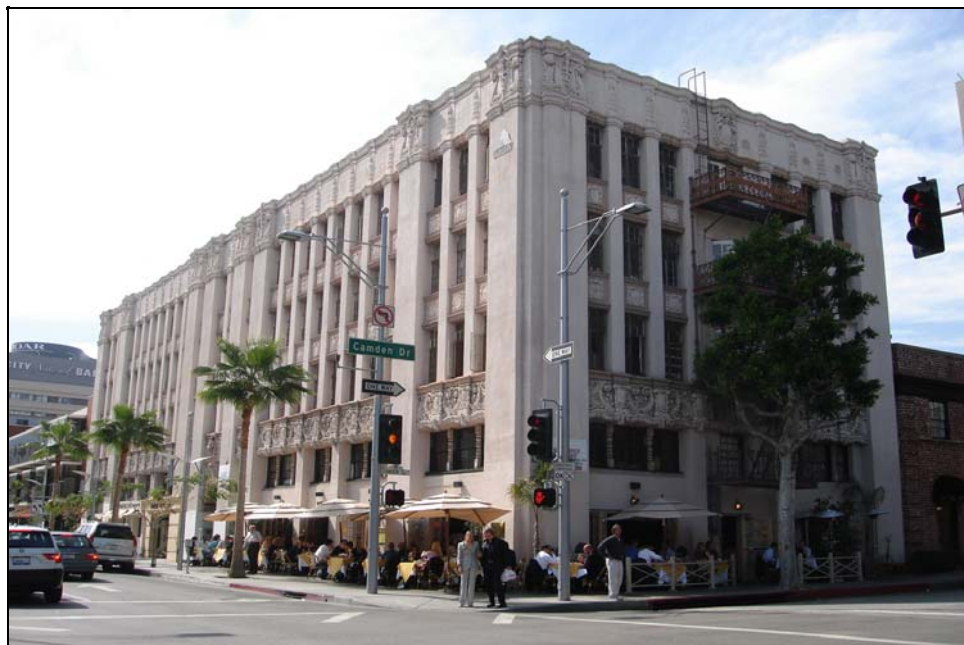
*This building appears in good condition with no significant alterations visible since the property was evaluated in the 1985-1986 survey and re-evaluated in the 2004 survey. It remains eligible for National Register, California Register, and local listing or designation.*

P5b Description/Date of Photo: South elevation, looking northwest/March 7, 2007

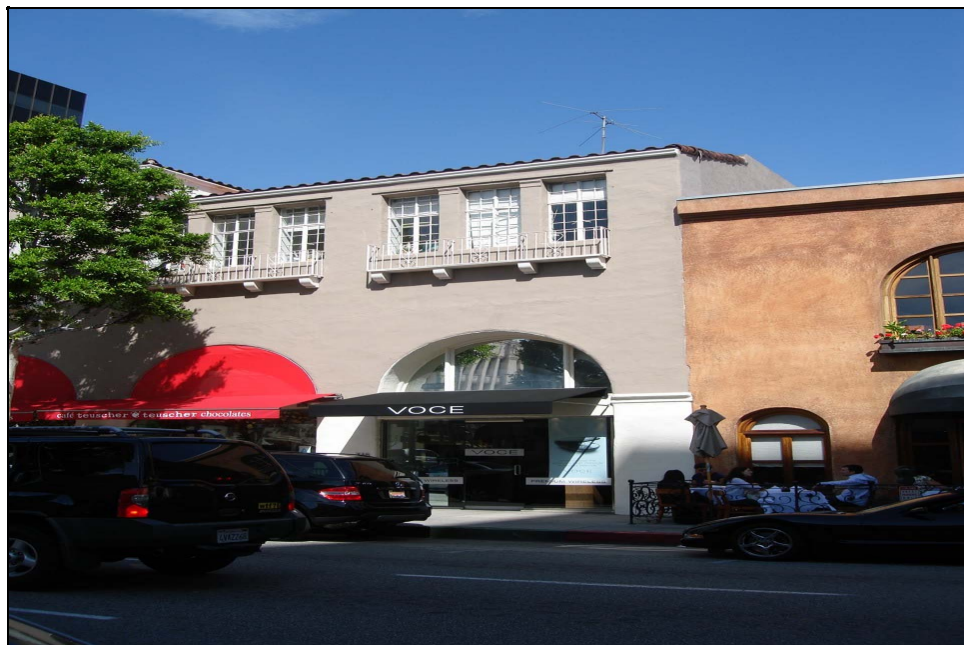
*This building appears in good condition with no significant alterations visible since the property was evaluated in the 1985-1986 survey and re-evaluated in the 2004 survey. It remains eligible for listing in the National Register, the California Register, and for local listing or designation.*

**P5b Description/Date of Photo:** *North and west elevations, looking southeast/March 7, 2007*

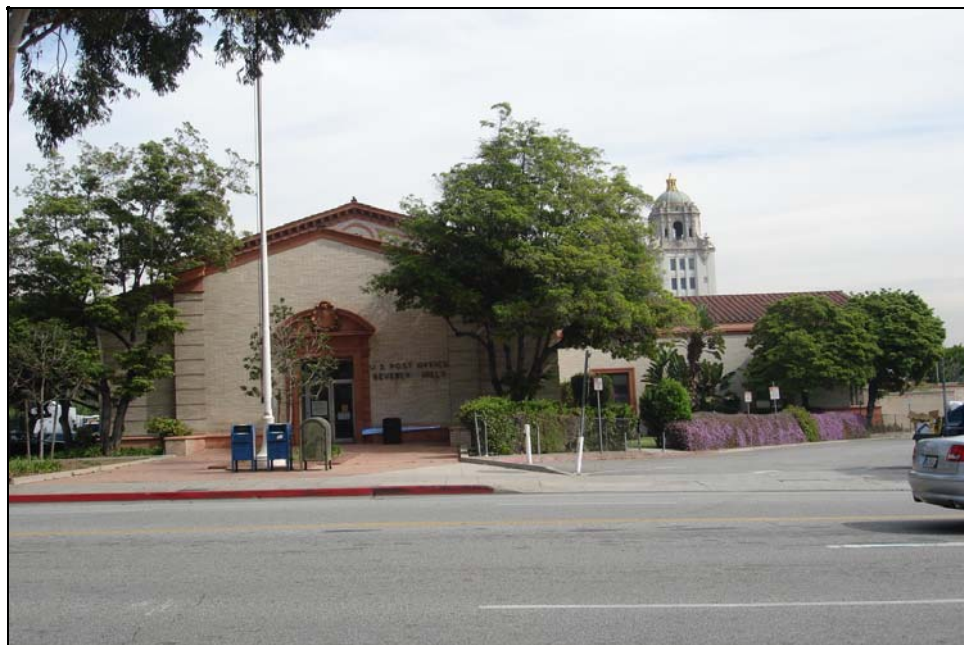
*This building appears in good condition with no significant alterations visible since the property was evaluated in the 1985-1986 survey and re-evaluated in the 2004 survey. It is listed in the National Register of Historic Places and remains eligible for local listing or designation.*

**P5b Description/Date of Photo:** West and south elevations, looking northeast/March 7, 2007

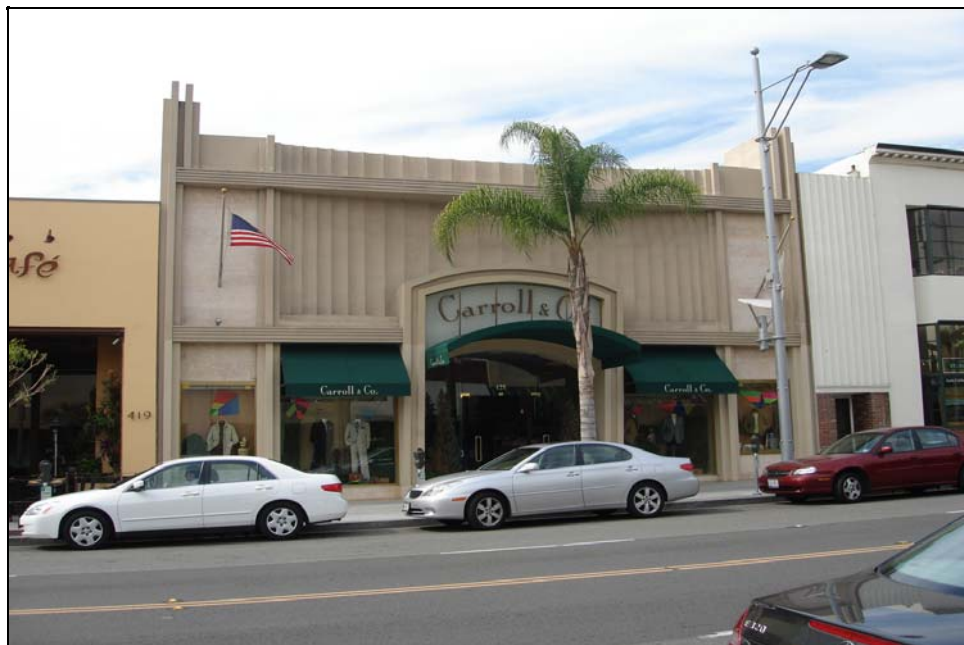
The 2004 survey reported that this property was demolished since it was first evaluated in the 1985-1986 survey.

P5b Description/Date of Photo: Replacement building on site, March 7, 2007

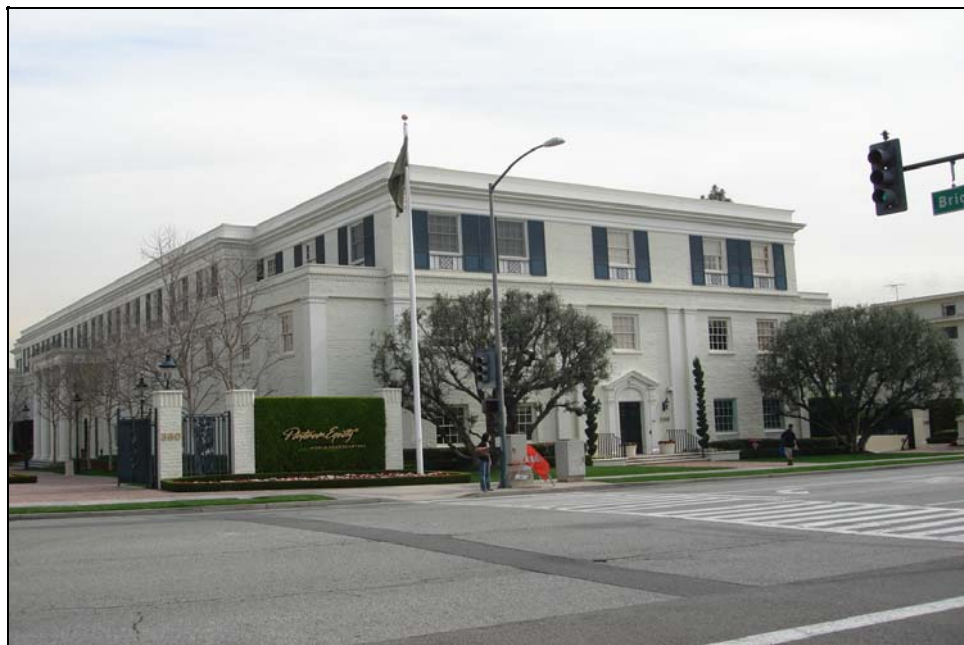
*This building appears in good condition with no significant alterations visible since the property was evaluated in the 1985-1986 survey and re-evaluated in the 2004 survey. It remains eligible for National Register, California Register, and for local listing or designation.*

**P5b Description/Date of Photo:** *North elevation, looking southeast/May 2004*

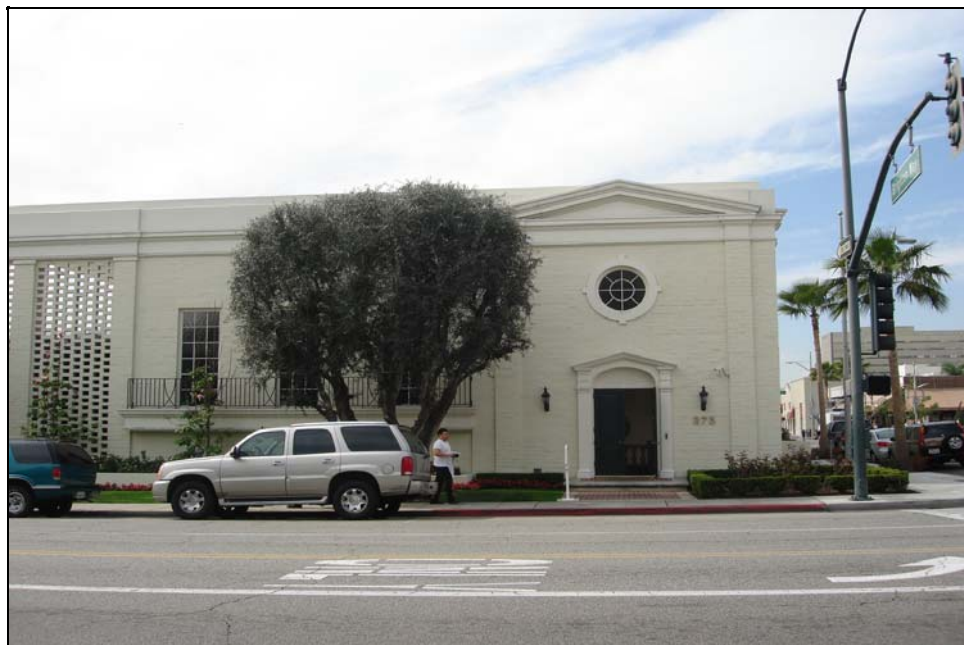
*This building appears in good condition with no significant alterations visible since the property was evaluated in the 1985-1986 survey and re-evaluated in the 2004 survey. It remains eligible for National Register, California Register, and for local listing or designation.*

**P5b Description/Date of Photo:** East and north elevations, looking southwest/March 7, 2007

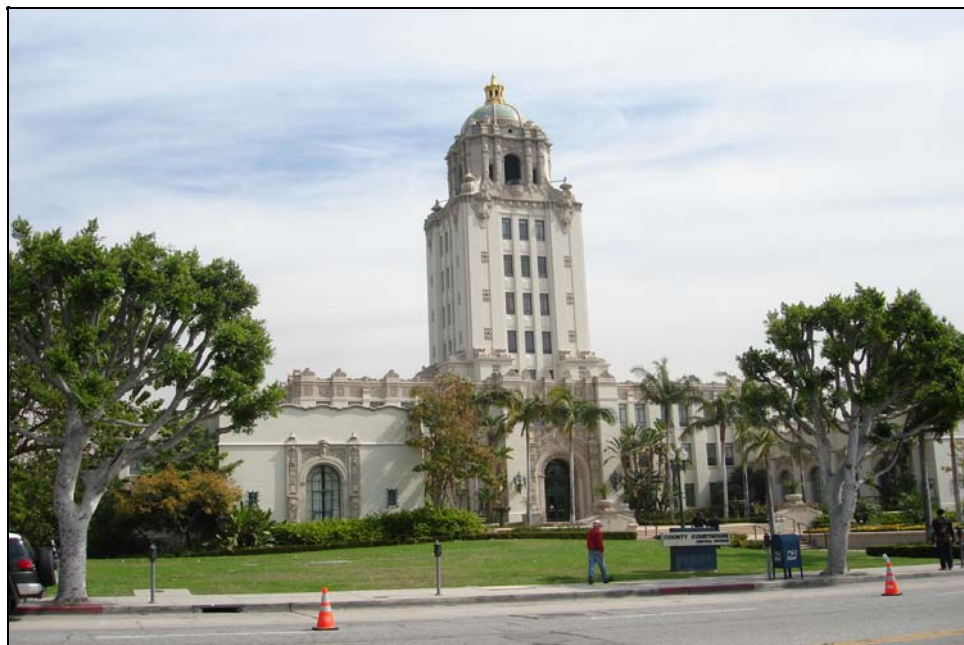
*There were extensive additions to the secondary (south and east) elevations of City Hall between the 1985-1986 and 2004 survey evaluations. However, the primary (west) elevation and west wing remain intact, in good condition, with a high degree of integrity. There do not appear to have been major modifications since the 2004 survey. Therefore, the building remains individually eligible for National Register, California Register, and local listing or designation under criteria related to events that have made a significant contribution to the broad patterns of the City's history, associations with the lives of historic personages, and for architectural significance.*

**P5b Description/Date of Photo:** West and south elevations, looking northeast/March 7, 2007

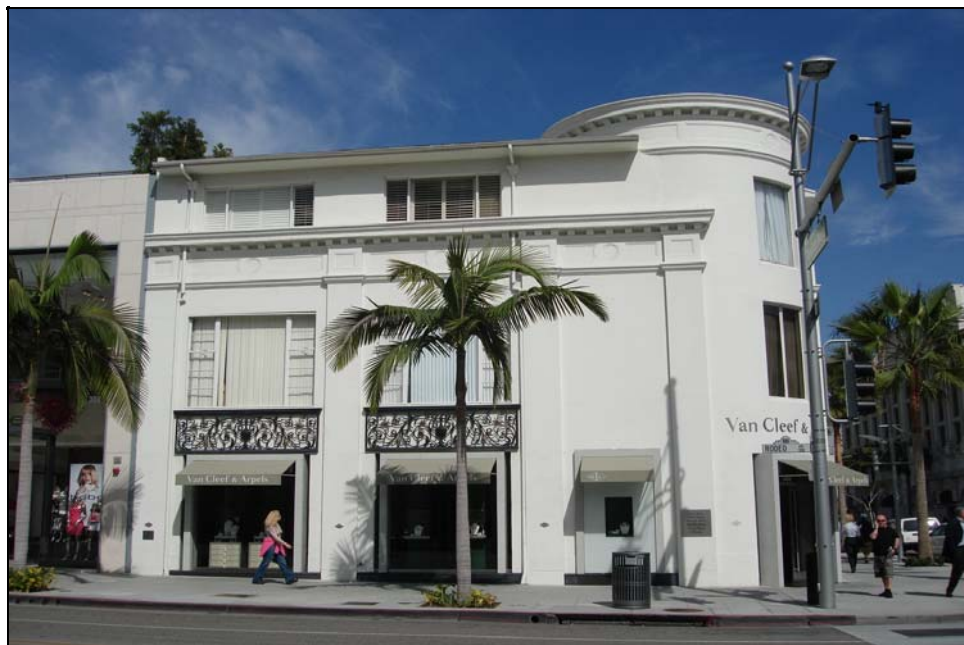
*Between the 1985-1986 and 2004 survey evaluations, the metal awnings on the street level were replaced with non-original canvas awning. In addition, the glazing of the storefronts located nearest to the main southwest corner entrance on the west and south elevations have been replaced. The remainder of the building appears unchanged since it was last evaluated in 2004. Because the modifications are in keeping with the sophisticated and stylized classicism of this mid-1930s building, the building remains eligible for local listing or designation.*

**P5b Description/Date of Photo:** *West and south elevations, looking northeast/March 7, 2007*

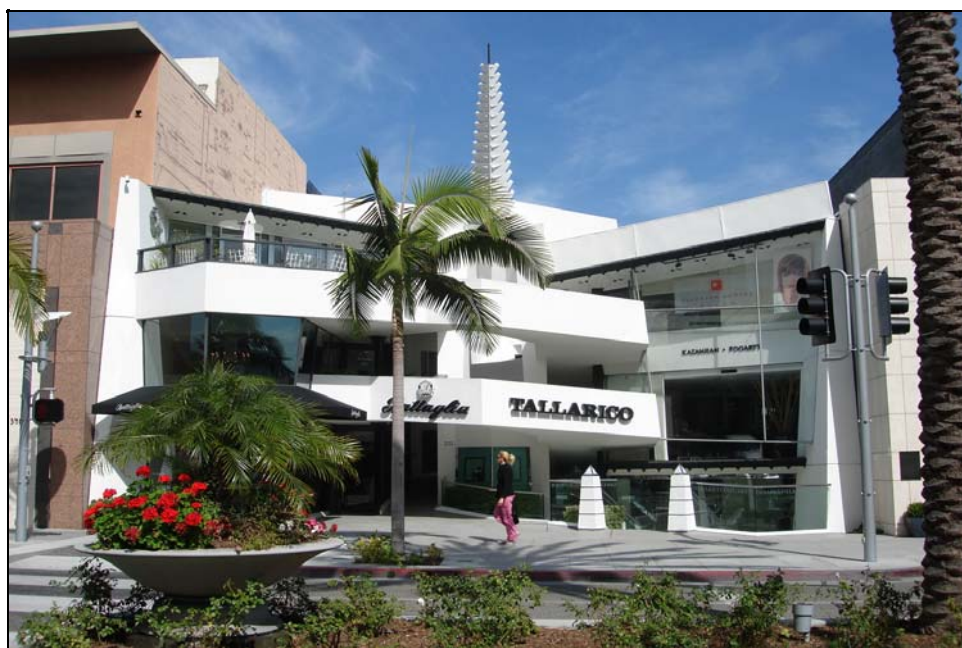
*Anderton Court, one of the few commercial buildings designed by Frank Lloyd Wright in the Los Angeles region, appears in good condition with no significant alterations visible since the property was evaluated in the 1985-1986 survey and re-evaluated in 2004. It is individually listed in the National Register (as of 5/14/04), and therefore automatically listed in the California Register, and appears eligible for local listing or designation.*

**P5b Description/Date of Photo:** West elevation, looking east/March 7, 2007

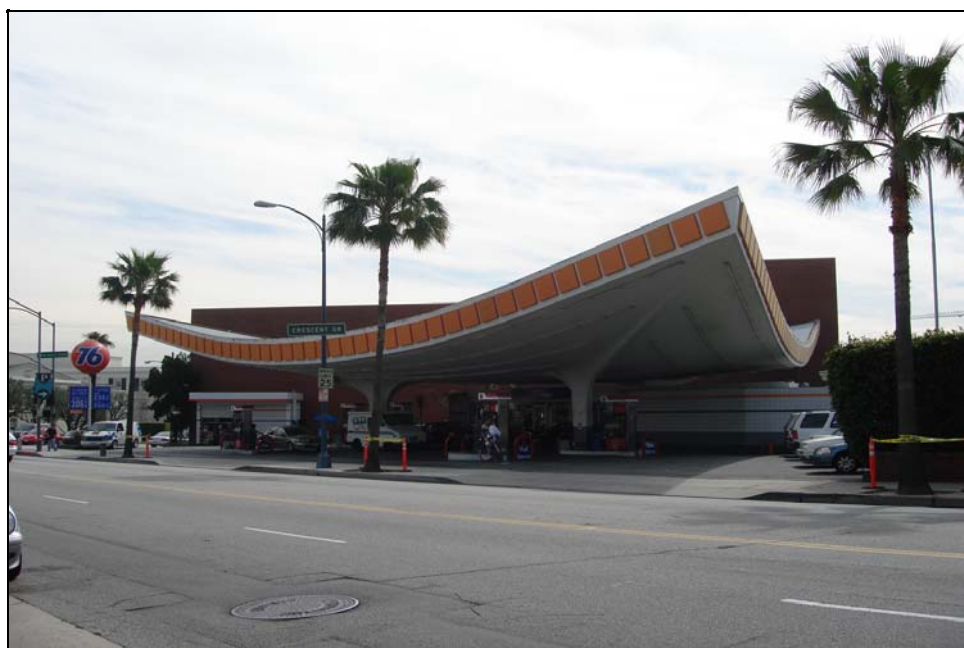
*This building appears in good condition with no significant alterations visible since the property was evaluated in the 1985-1986 survey and re-evaluated in the 2004 survey. The property meets criteria related to exceptional significance due to its association with master architects William Pereira and the firm's design director Gin Wong, and its excellent and unique Modern architectural design as applied to a service station. Therefore, the building appears individually eligible for National Register, California Register, and local listing or designation.*

P5b Description/Date of Photo: North elevation, looking south/March 7, 2007

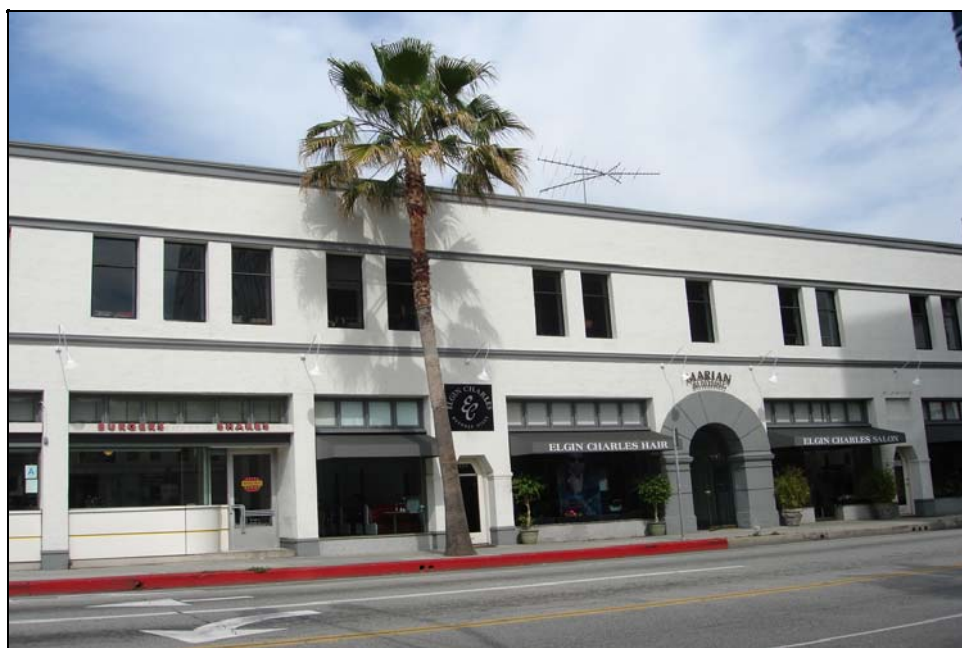
*Between the 1985-1986 and 2004 survey evaluations, alterations were made to the frames and glazing of windows on both stories. Metal-framed windows and non-original glazing replaced the multi-pane casements topped by transoms that previously punctuated the second story elevation. Similarly, the frames and glazing of the storefronts are no longer original, particularly those storefronts located on the southwest corner associated with the Johnny Rockets restaurant. Nonetheless, because the modifications are in keeping with the vernacular commercial style of this late 1920s building, and the elaborately molded arched entrances remain unaltered, the building remains eligible for local listing or designation.*

**P5b Description/Date of Photo:**    West and south elevations, looking northeast/March 7, 2007

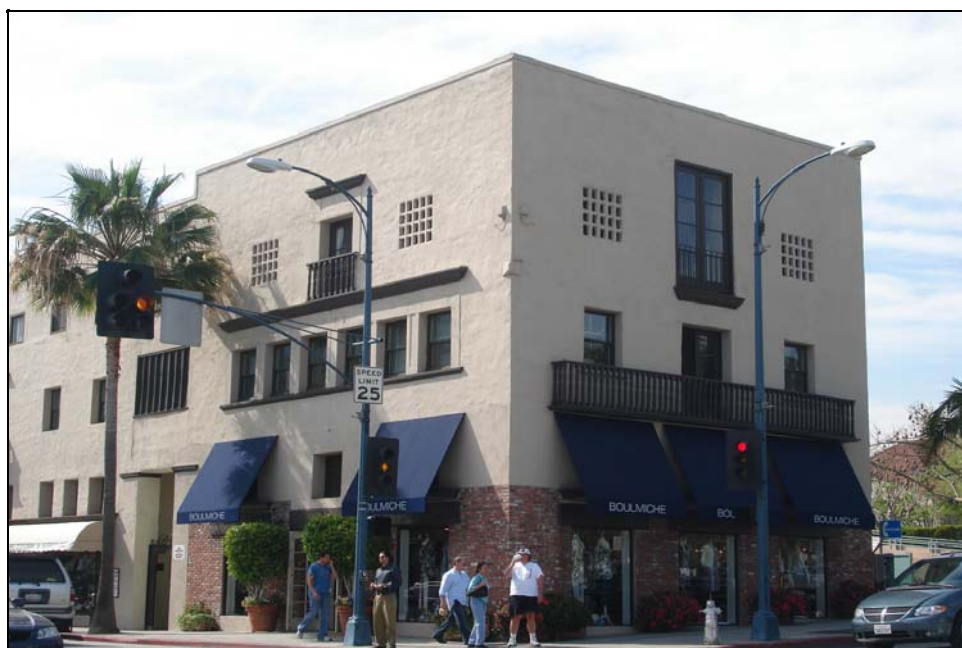
*Between the survey evaluations of the property in 1985-1986 and 2004, alterations occurred to the frames and glazing of windows on the fourth story. Metal-framed windows and non-original glazing have replaced the wood-framed casements that previously punctuated the fourth story elevation. Fenestration on the second and third floors appears to be unchanged since the last survey, however, storefronts had already been altered by 1985-1986. Nonetheless, the modifications do not greatly detract from the vernacular commercial style of this mid-1920s building, therefore, the building remains eligible for local listing or designation. No major modifications have occurred since the 2004 survey.*

**P5b Description/Date of Photo:** South and west elevations, looking northeast/March 7, 2007

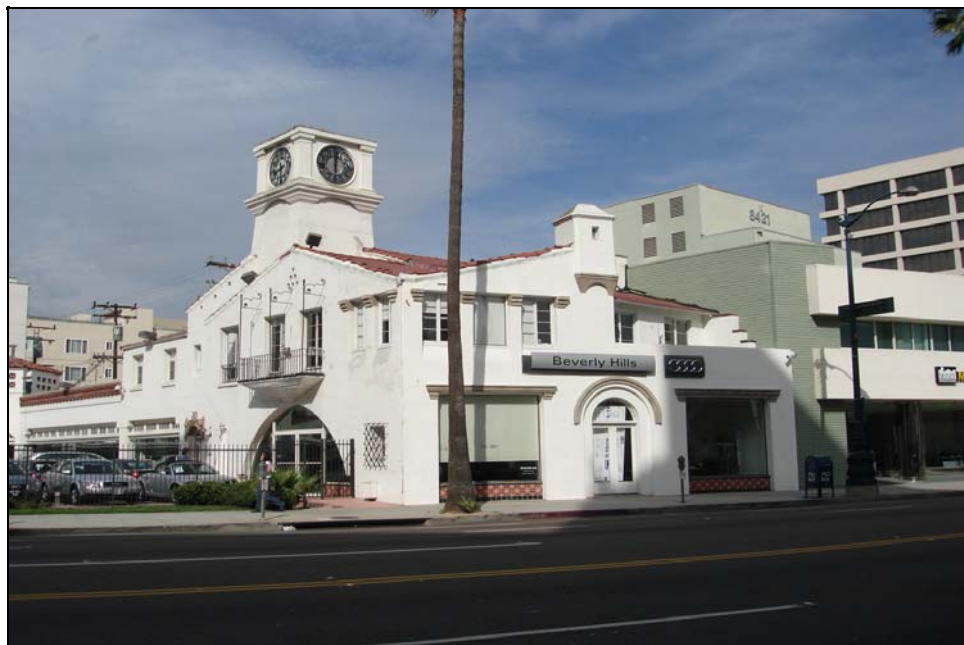
*This building appears in good condition with no significant alterations visible since the property was evaluated in the 1985-1986 survey and re-evaluated in the 2004 survey. Note that the 1985-1986 survey identified modifications to the storefronts and arched entrance to accommodate vehicle service and offices associated with an automobile showroom. It remains eligible for local listing or designation.*

**P5b Description/Date of Photo:**    West elevation, looking northeast/March 7, 2007

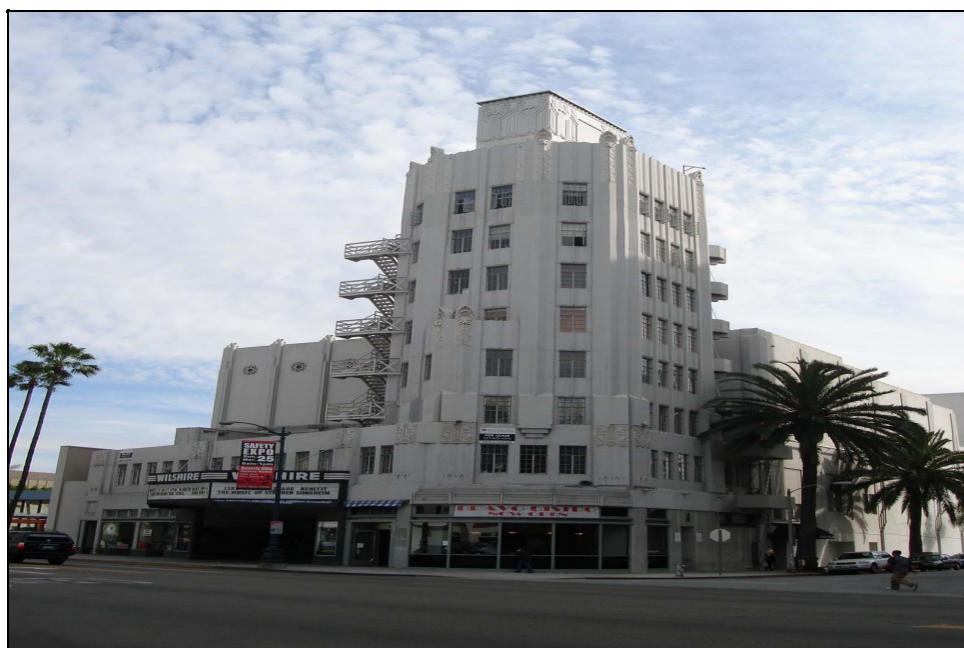
*The Wilshire Theatre building designed by renowned architect S. Charles Lee is primarily unaltered since the property was evaluated in the 1985-1986 survey and re-evaluated in the 2004 survey. The major exception is the street level main entrance area where metal-framed entry doors and glazing have replaced the original entrance elements. Most of the storefronts and visible elevations above the ground floor level appear unchanged since the previous survey. Therefore, because the building is an excellent example of a motion picture theatre designed in the Art Deco style, is associated with a master architect, and exhibits an overall high level of physical integrity, it appears to be individually eligible for National Register, California Register, and local listing or designation. Additionally, the building remains a contributor to a potential historic district defined as the Beverly Hills Neighborhood Theatres Thematic Grouping that is eligible for local listing or designation.*

P5b Description/Date of Photo: North elevation, looking south/March 7, 2007

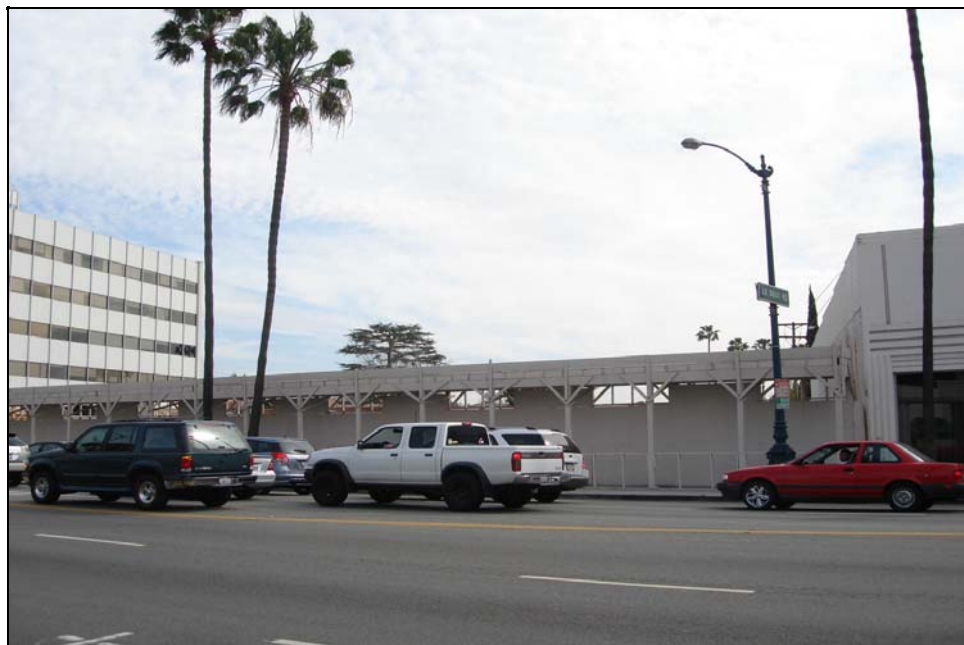
*This property was demolished since it was last evaluated in the 2004 survey. It no longer appears individually eligible for listing in the National Register, California Register and for local designation. It no longer is a contributor to a potential historic district defined as the Beverly Hills Neighborhood Theatres Thematic Grouping.*

**P5b Description/Date of Photo:** Post demolition, March 7, 2007

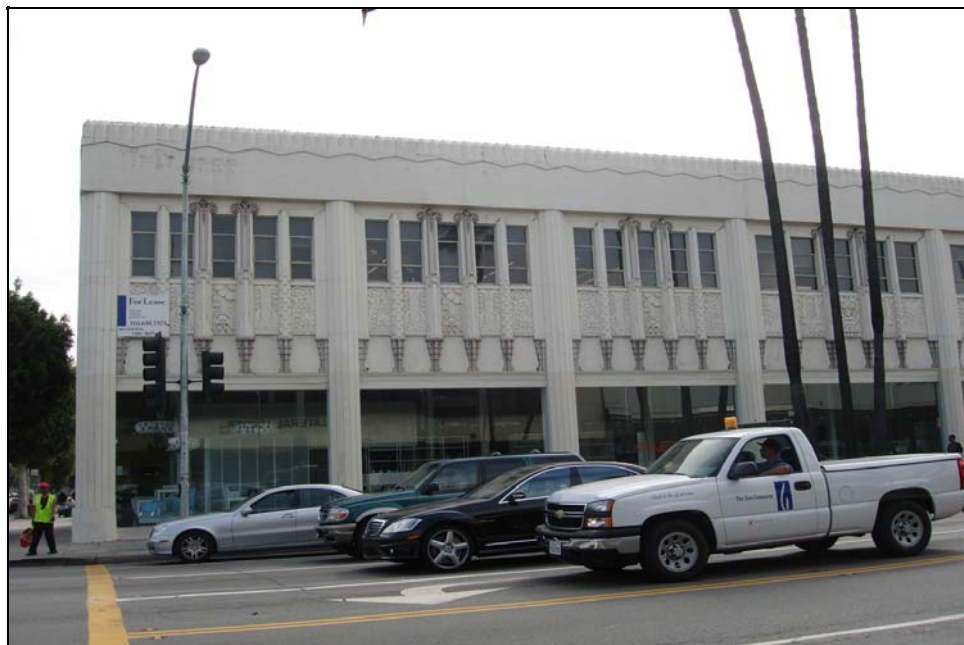
*Although the storefronts were altered between the 1985-1986 survey and 2004 survey evaluations, the upper floors of the primary (north and east) elevations, which contain much of the architectural detailing, appear in good condition with no significant alterations visible. It has not been substantially modified since the 2004 survey. It appears individually eligible for local listing or designation.*

**P5b Description/Date of Photo:** *East and north elevations, looking southwest/March 7, 2007*

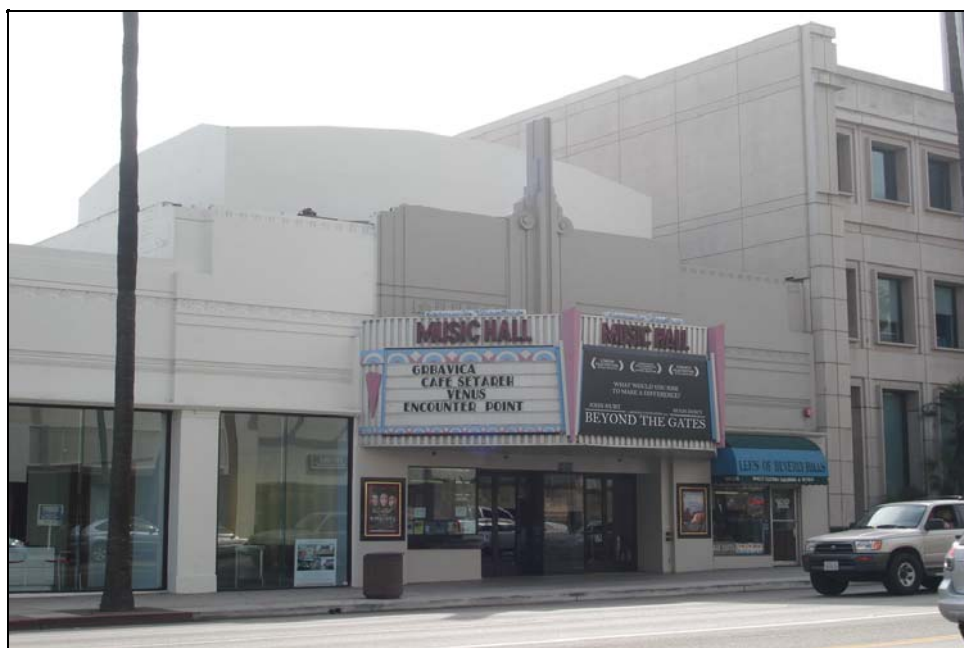
*This building appears in good condition with no significant alterations visible since the property was evaluated in the 1985-1986 survey and re-evaluated in the 2004 survey. It appears individually eligible for local listing or designation and remains a contributor to a potential historic district defined as the Beverly Hills Neighborhood Theatres Thematic Grouping that is eligible for local listing or designation.*

**P5b Description/Date of Photo:** North elevation, looking southwest/March 7, 2007

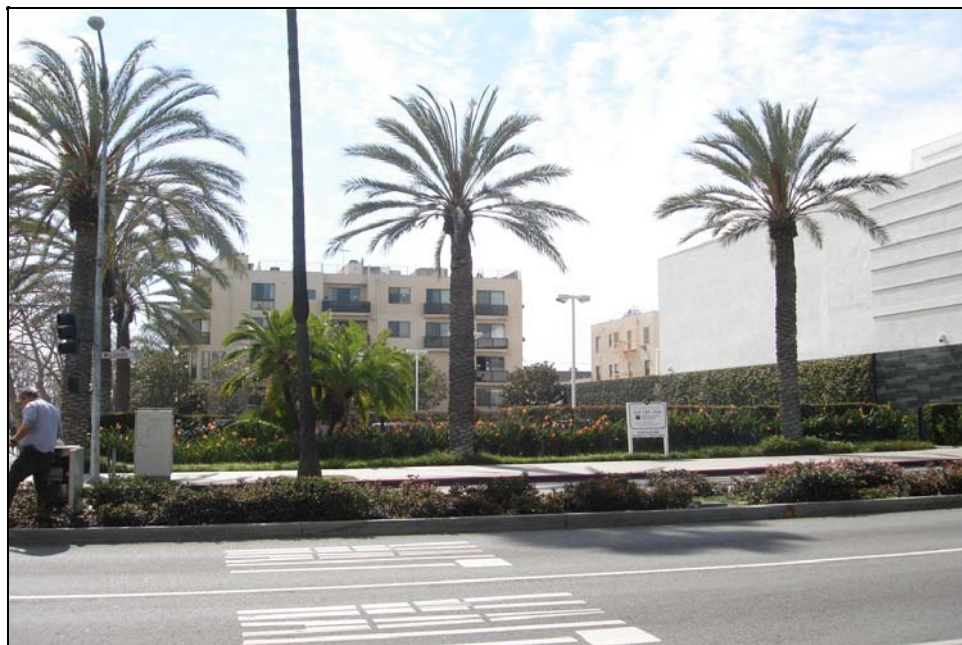
*This property was demolished since it was evaluated in the 1985-1986 survey.*

P5b Description/Date of Photo: Post Demolition photo, March 7, 2007.

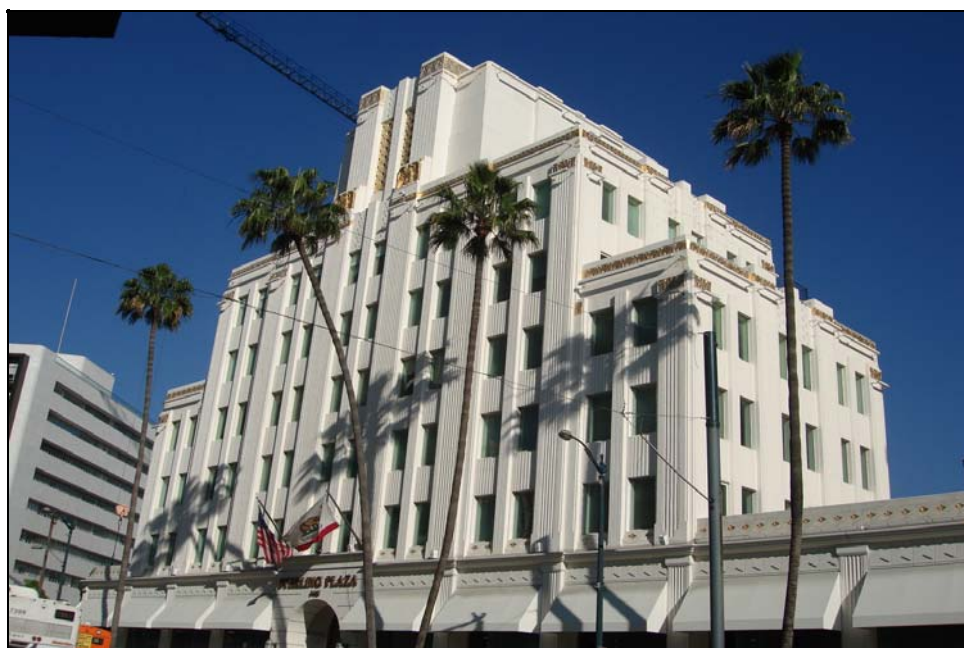
*Since the building was evaluated in the 1985-1986 survey, but prior to the re-evaluation in the 2004 survey, the upper floors have been reglazed in kind, the ground floor storefronts reglazed, and the building entry archway reconstituted. Other than these modifications, the building appears in good condition. It appears individually eligible for listing in the California Register and for local listing or designation.*

P5b Description/Date of Photo: South elevation, looking northwest/March 7, 2007

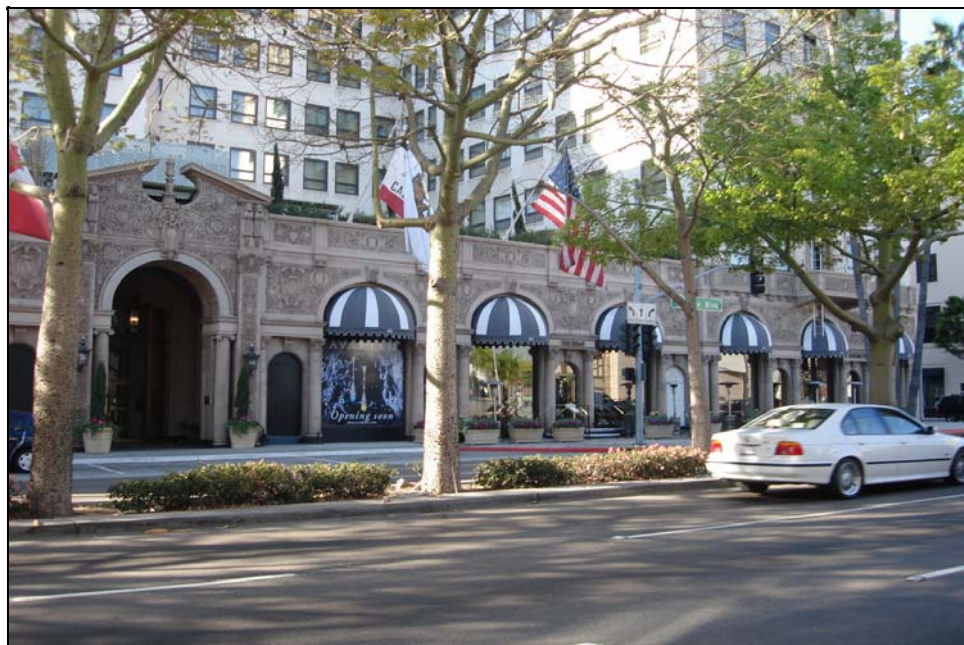
*This building appears in good condition with no significant alterations visible since the property was evaluated in the 1985-1986 survey and reevaluated in the 2004 survey. It is listed in the National Register and California Register and remains eligible for local listing or designation.*

P5b Description/Date of Photo: North elevation, looking south/March 7, 2007

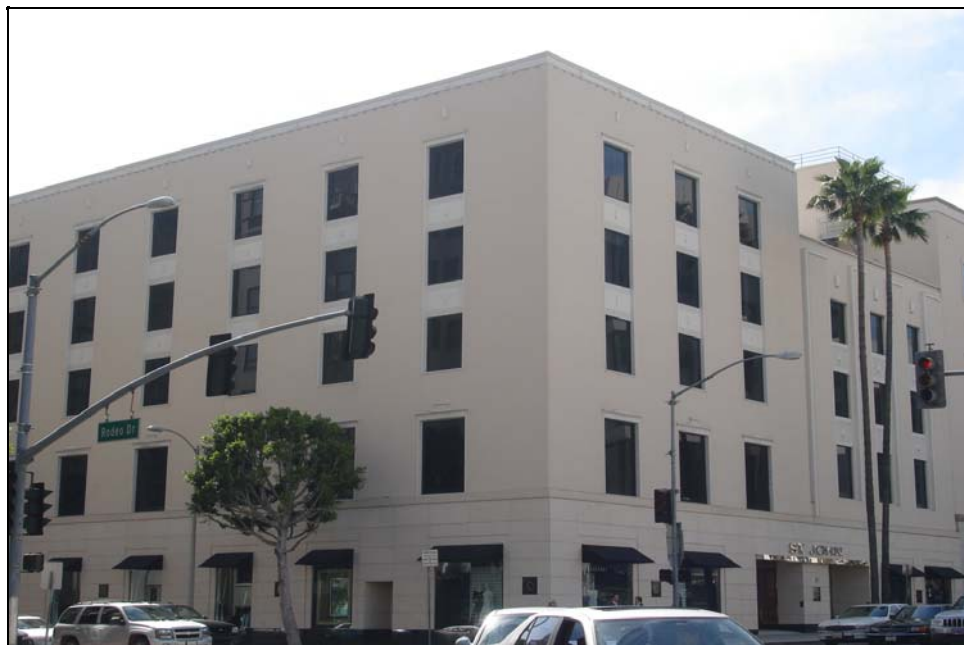
*Between the 1985-1986 and 2004 survey evaluations, there were alterations to the storefronts and fenestration. Specifically, the flat projecting canopy that shaded storefronts along the primary (north) elevation and wrapped around the building's northeast corner has been removed. Canvas awnings now shade the storefronts on the north and east elevations. Further, upper floor multi-pane sash windows have been replaced with single-pane fixed glazing. Nonetheless, the overall integrity of the building remains high and thus the property remains a contributor to a potential historic potential historic district defined as the Wilshire Boulevard Speciality Stores Thematic Grouping that is eligible for local listing or designation. No major modifications have occurred since the 2004 evaluation.*

P5b Description/Date of Photo: North and east elevations, looking southwest/March 7, 2007

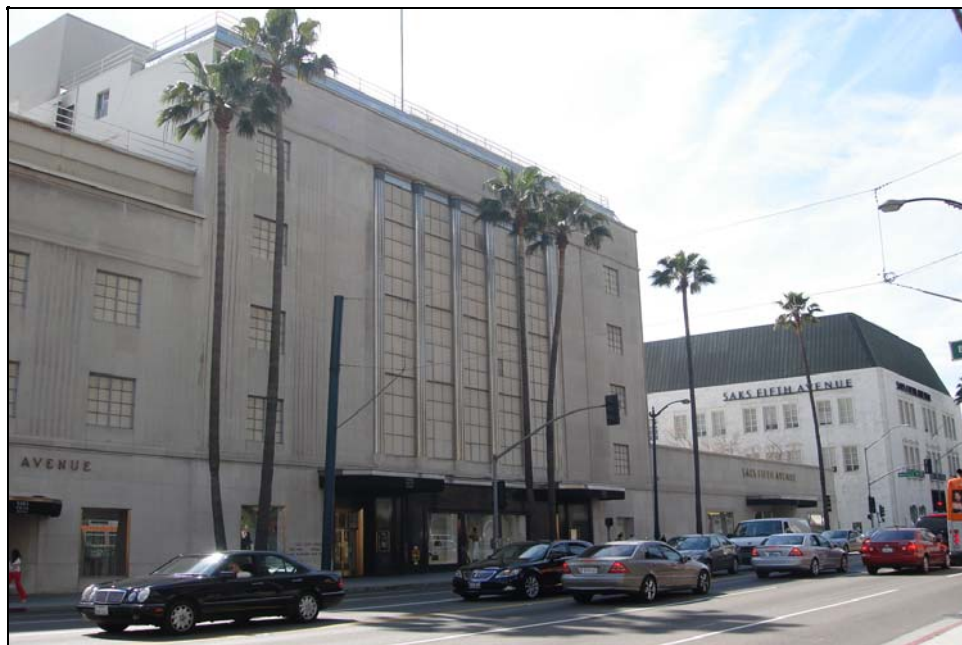
*This building appears in good condition. Visible alterations are located on the west (secondary) elevation and include the addition of a six-story elevator shaft, a one-story retail store that emulates the original buildings, and some recladding. There appear to be no significant alterations visible to the north and east (primary) elevations since the property was evaluated in the 1985-1986 survey and re-evaluated in the 2004 survey. The building appears eligible for individual listing in the National Register and California Register at the local level of significance and for local designation. It also remains a contributor to a potential historic potential historic district defined as the Wilshire Boulevard Speciality Stores Thematic Grouping that is eligible for local listing or designation.*

P5b Description/Date of Photo: North and east elevations, looking southwest/March 7, 2007

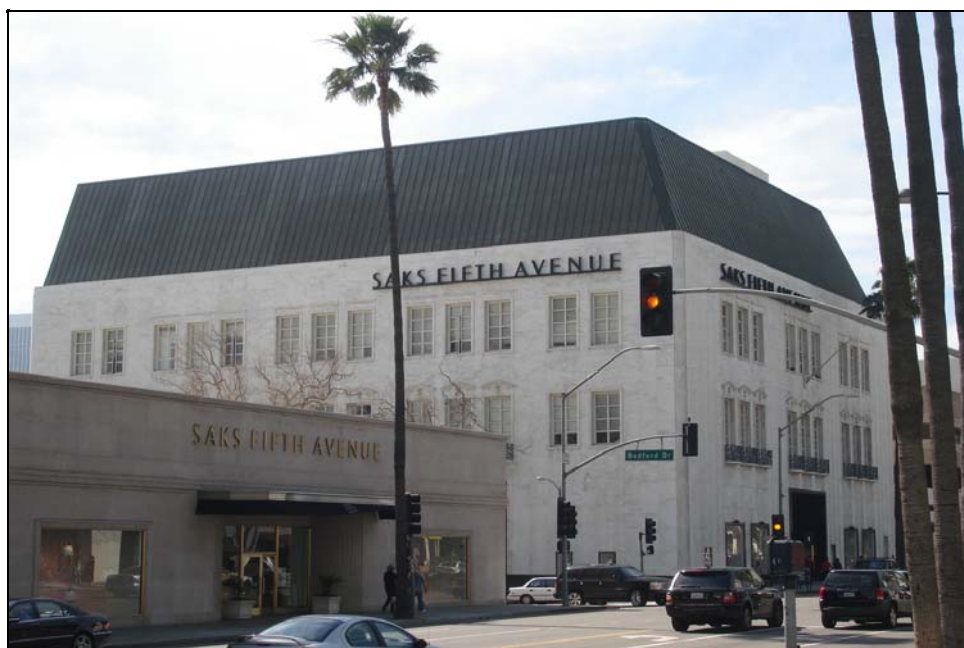
*This building appears in good condition with no significant alterations visible since the property was evaluated in the 1985-1986 survey and re-evaluated in the 2004 survey. The building appears eligible for individual listing in the National Register and California Register at the local level of significance and for local designation. It also remains a contributor to a potential historic district defined as the Wilshire Boulevard Speciality Stores Thematic Grouping that is eligible for local listing or designation..*

P5b Description/Date of Photo: East and north elevations, looking southwest/March 7, 2007

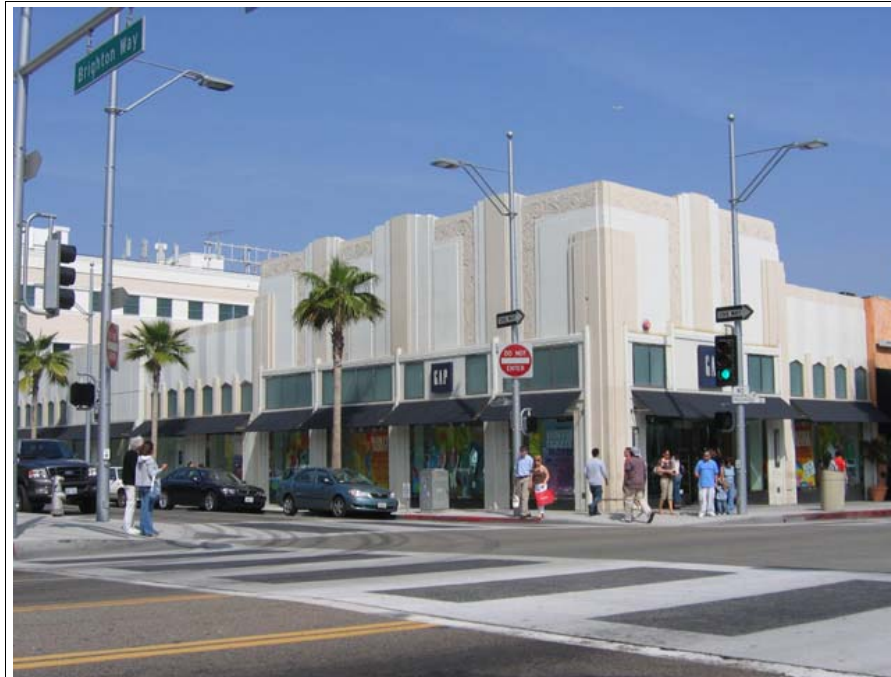
\* P3a. Description: (Describe resource and its major elements. Include design, materials, condition, alterations, size, setting, and boundaries.)  
Contributor to a potential California Register district (Criterion 3) of Art Deco/Moderne buildings.

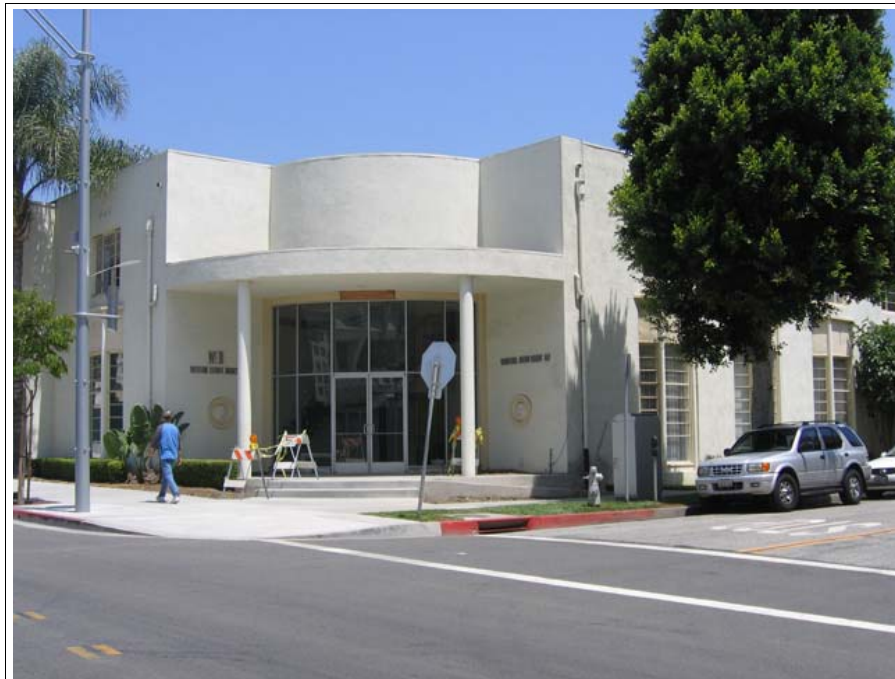
- \* **P3a. Description:** (Describe resource and its major elements. Include design, materials, condition, alterations, size, setting, and boundaries.)  
Contributor to a potential California Register district (Criterion 3) of Art Deco/Moderne buildings.

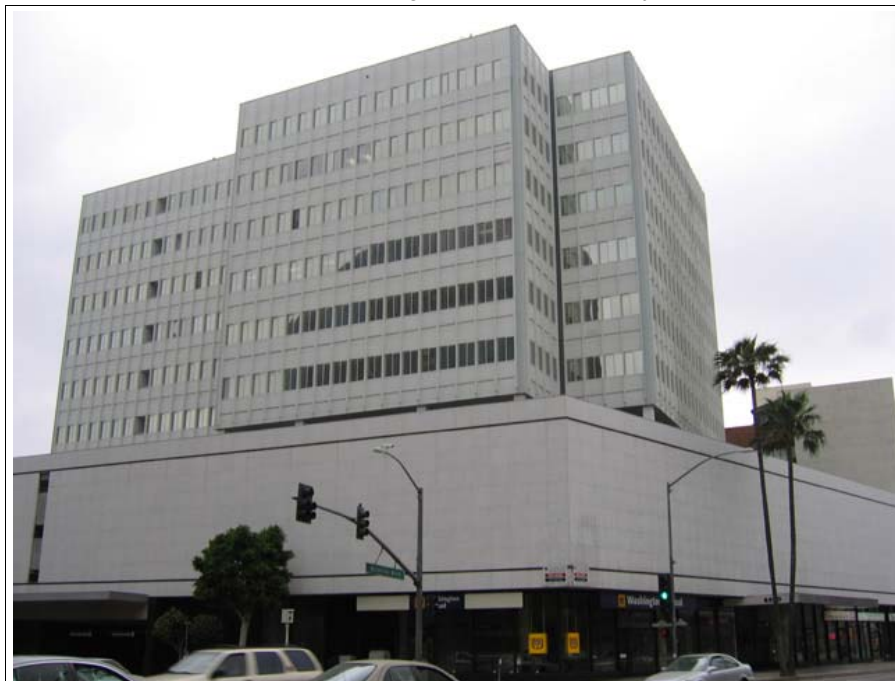
- \* **P3a. Description:** (Describe resource and its major elements. Include design, materials, condition, alterations, size, setting, and boundaries.)  
Contributor to a potential California Register district (Criterion 3) of Post World War II modern office buildings.
