# City of Beverly Hills Historic Resources Survey Report

## *Survey Area 5: Commercial Properties*

Part I: Historic Resources Survey Update

Part II: Area 5: Commercial Property Survey

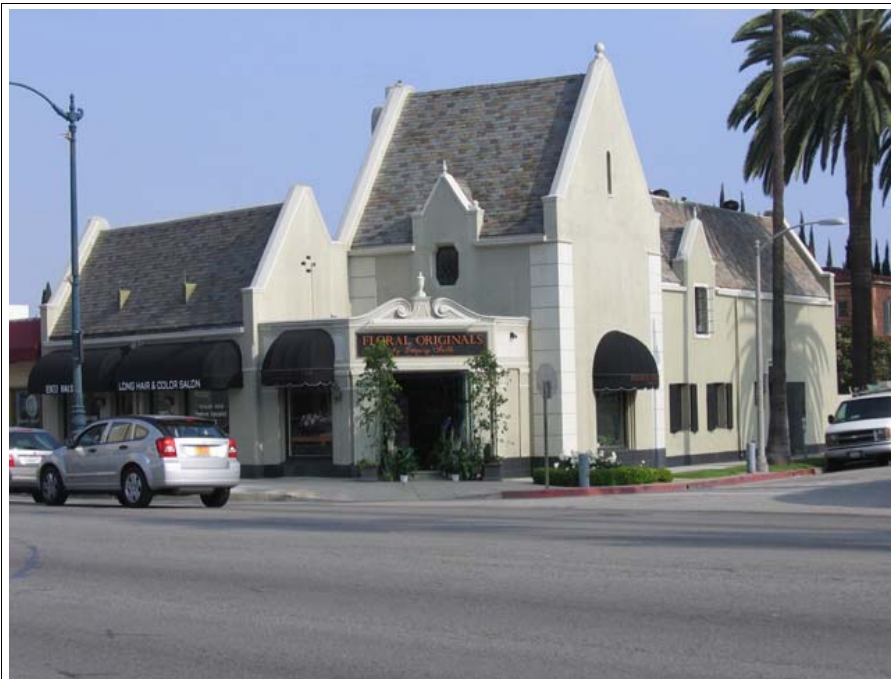
\* P3a. Description: (Describe resource and its major elements. Include design, materials, condition, alterations, size, setting, and boundaries.)  
Contributor to a potential California Register district (Criterion 3) of Regency Revival buildings.

Original Owner: Kadler; Mr. & Mrs. Peter  
Architect: Schroeder; Albert J.  
Builder: Calhoun-Hastings Ltd.

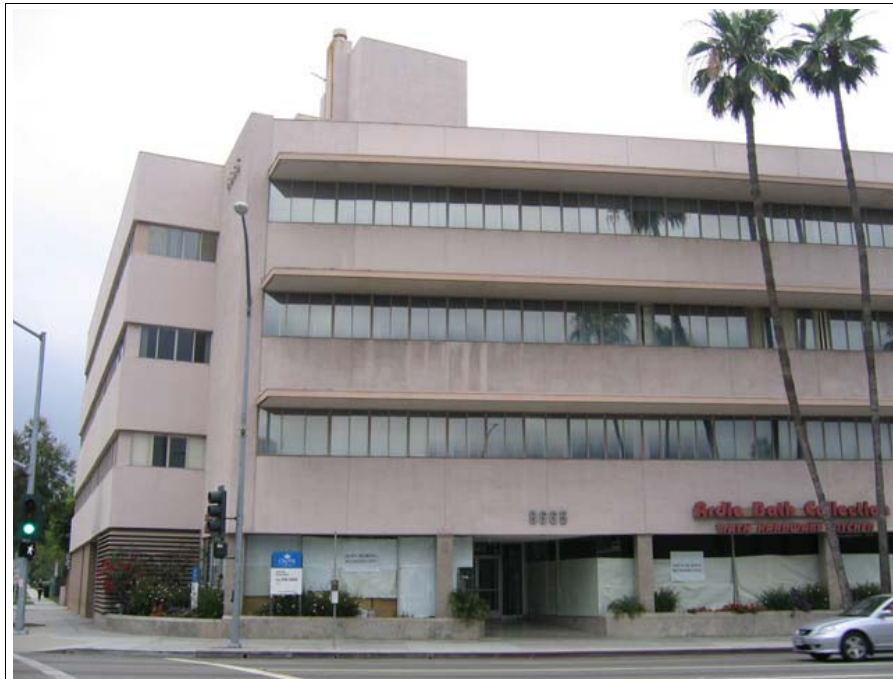
\* P3a. Description: (Describe resource and its major elements. Include design, materials, condition, alterations, size, setting, and boundaries.)  
Contributor to potential California Register district (Criterion 3) of Post World War II modern office buildings.

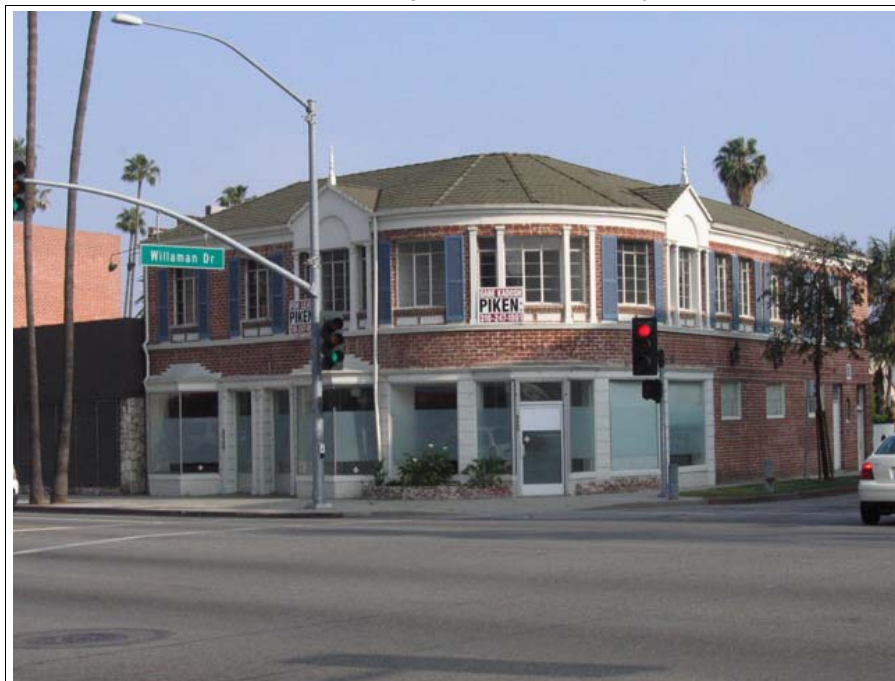
\* P3a. Description: (Describe resource and its major elements. Include design, materials, condition, alterations, size, setting, and boundaries.)  
Contributor to a potential California Register district (Criterion 3) of Regency Revival buildings.

Original Owner: Haugh; Walter D.  
Architect: Postle & Postle  
Builder: Hillis; Frank

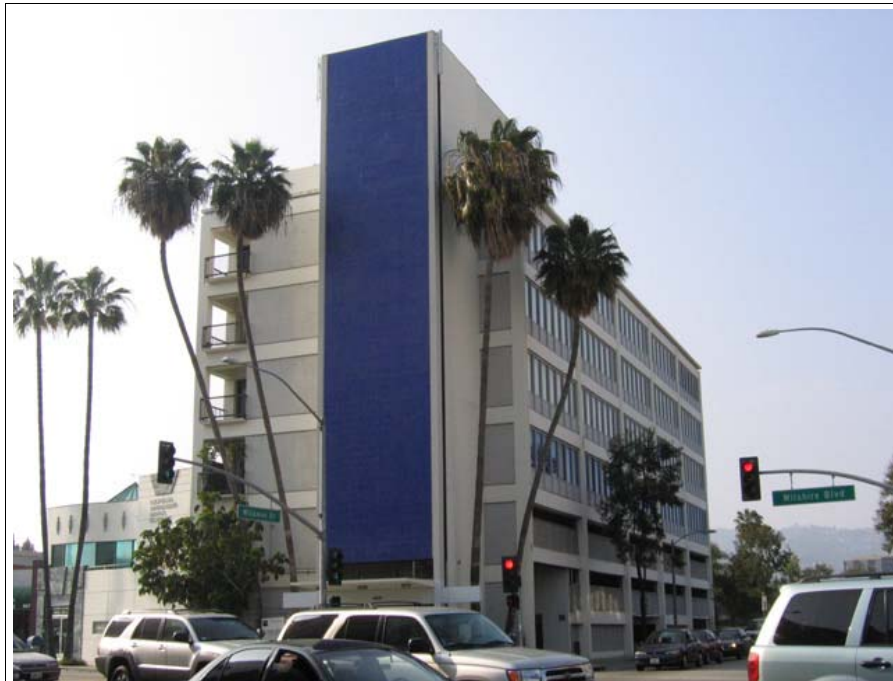
\* P3a. Description: (Describe resource and its major elements. Include design, materials, condition, alterations, size, setting, and boundaries.)  
Contributor to a potential California Register district (Criterion 3) of Post World War II modern office buildings. Architect:  
Richard Dorman Associates.

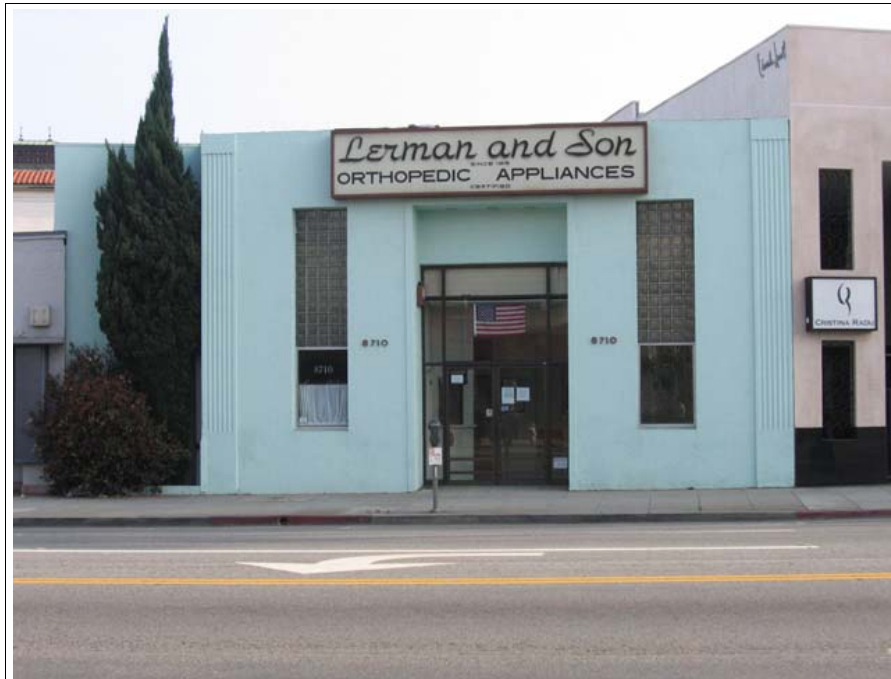
\* P3a. Description: (Describe resource and its major elements. Include design, materials, condition, alterations, size, setting, and boundaries.)  
Contributor to a potential California Register district (Criterion 3) of Art Deco/Moderne buildings.

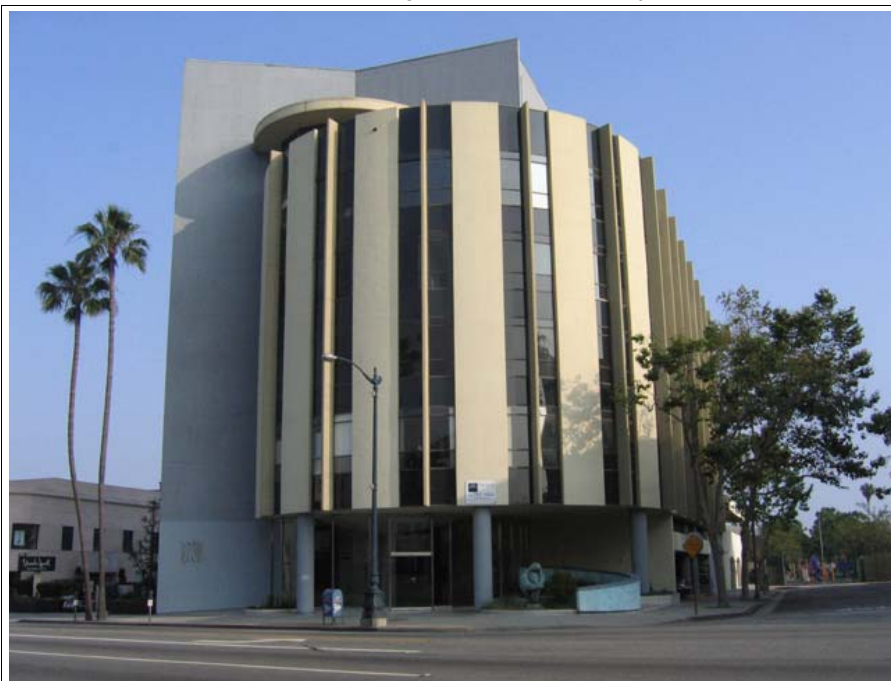
\* P3a. Description: (Describe resource and its major elements. Include design, materials, condition, alterations, size, setting, and boundaries.)  
Contributor to a potential California Register district of (Criterion 3) Post World War II modern office buildings. Architect:  
Sidney Eisenshtat.

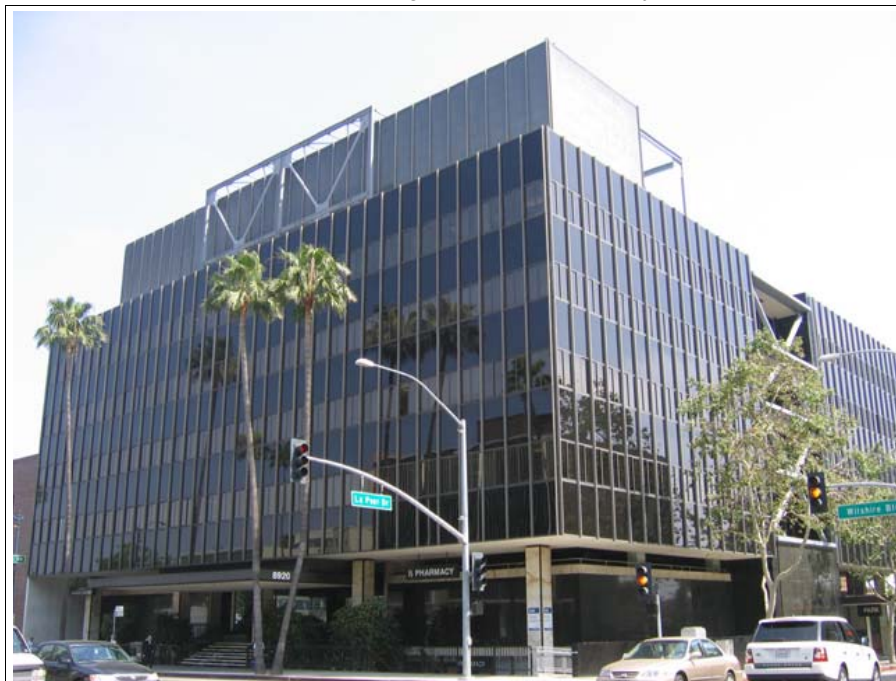
\* P3a. Description: (Describe resource and its major elements. Include design, materials, condition, alterations, size, setting, and boundaries.)  
Contributor to a potential California Register district of (Criterion 3) Post World War II modern office buildings. Architect:  
Palmer and Krisel.

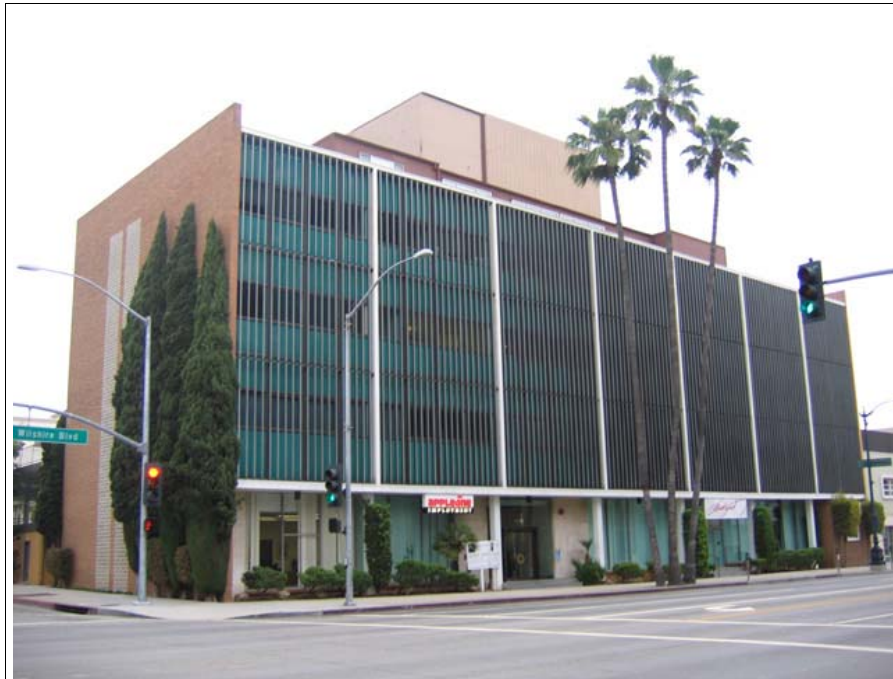
\* P3a. Description: (Describe resource and its major elements. Include design, materials, condition, alterations, size, setting, and boundaries.)  
Contributor to a potential California Register district (Criterion 3) of Post World War II modern office buildings.

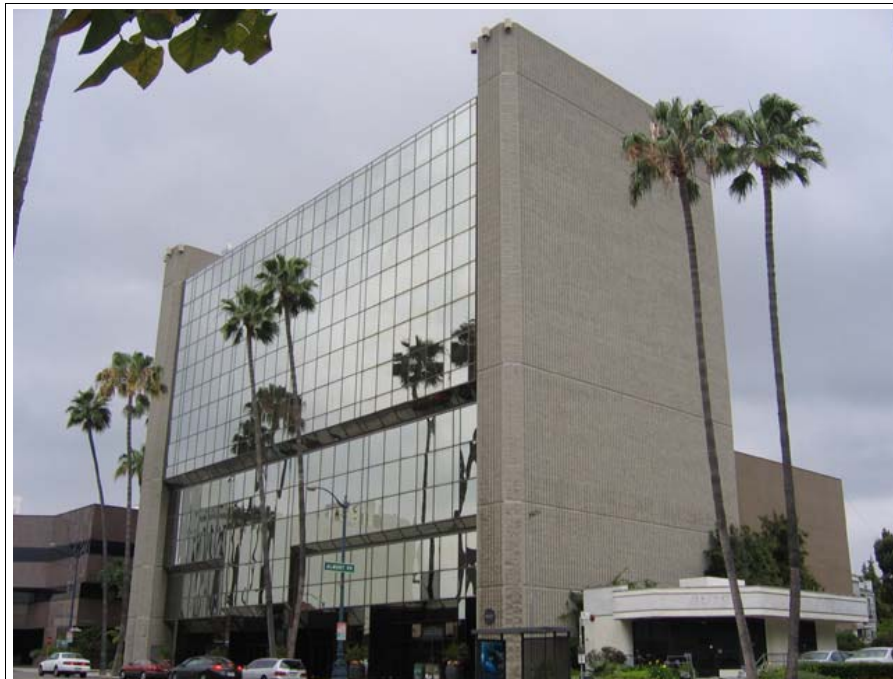
\* P3a. Description: (Describe resource and its major elements. Include design, materials, condition, alterations, size, setting, and boundaries.)  
Contributor to a potential California Register district (Criterion 3) of Post World War II modern office buildings. Architect:  
Sidney Eisenshtat.

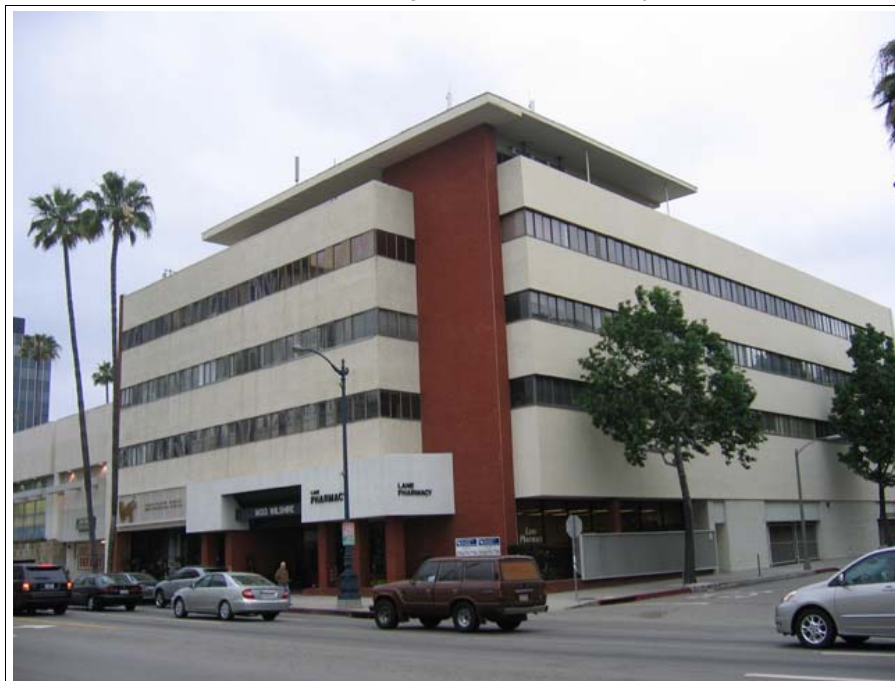
\* P3a. Description: (Describe resource and its major elements. Include design, materials, condition, alterations, size, setting, and boundaries.)  
Contributor to a potential California Register district (Criterion 3) of Post World War II modern office buildings.

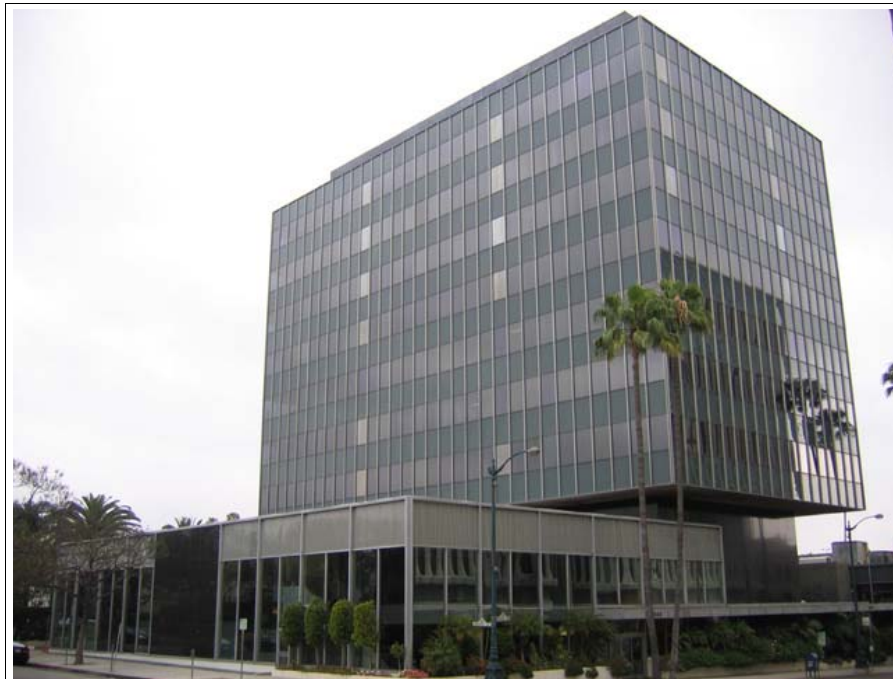
\* P3a. Description: (Describe resource and its major elements. Include design, materials, condition, alterations, size, setting, and boundaries.)  
Appears to be individually eligible for the California Register under Criterion 3, as a good intact example of the work of a master architectural firm, Pereira and Luckman, as well as being a contributor to potential California Register district (Criterion 3) of Post World War II modern office buildings.

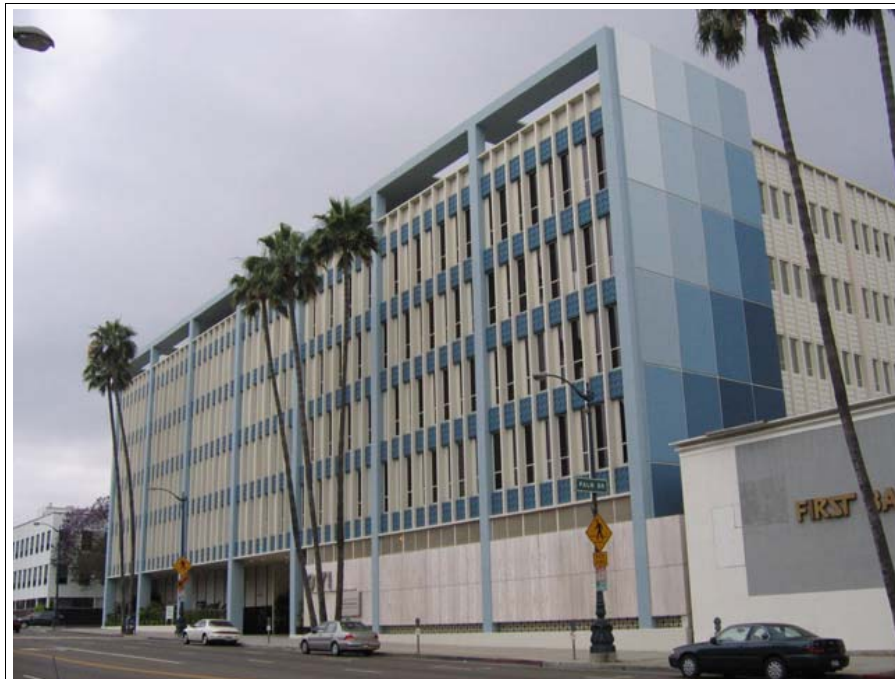
- \* **P3a. Description:** (Describe resource and its major elements. Include design, materials, condition, alterations, size, setting, and boundaries.) Contributor to a potential California Register district (Criterion 3) of Post World War II modern office buildings. Architect: Sidney Eisenshtat.

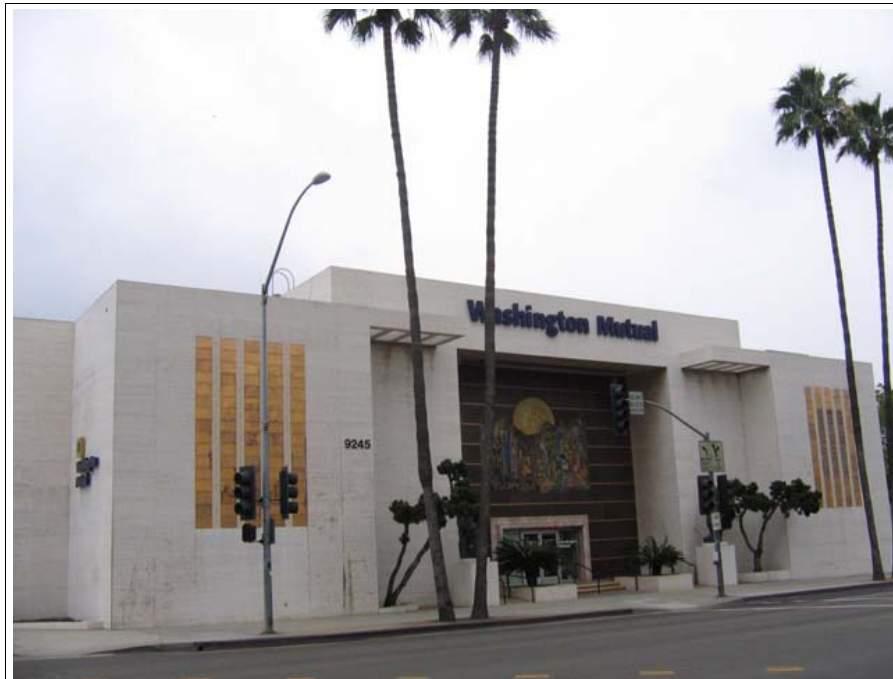
\* P3a. Description: (Describe resource and its major elements. Include design, materials, condition, alterations, size, setting, and boundaries.)  
Appears to be individually eligible for the California Register under Criterion 3, as an important example of the work of a master designer, Millard Sheets, and as one of the oldest remaining, and intact examples of the Home Savings and Loan buildings.

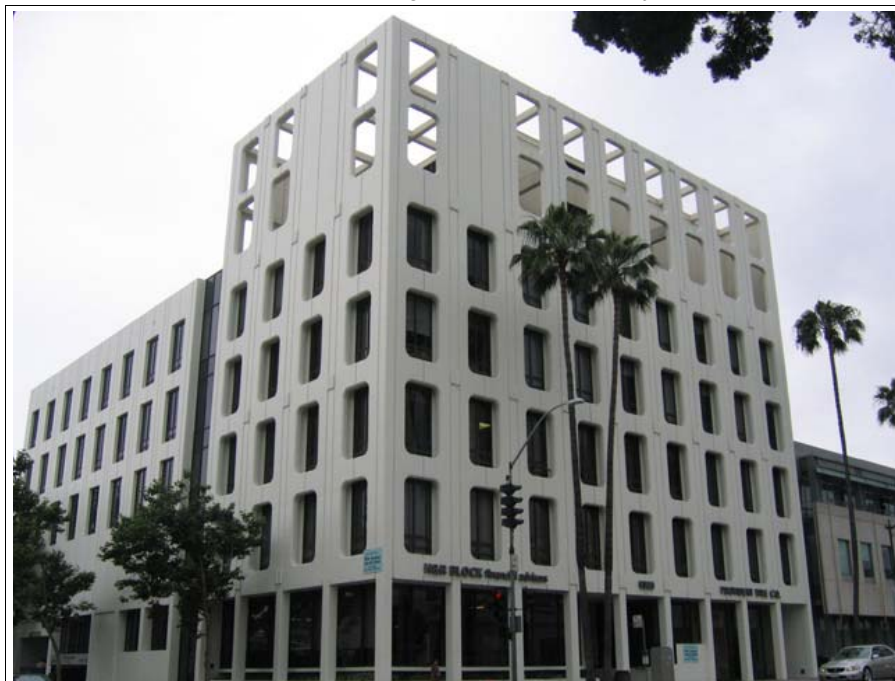
\* P3a. Description: (Describe resource and its major elements. Include design, materials, condition, alterations, size, setting, and boundaries.)  
Contributor to a potential California Register district of (Criterion 3) Post World War II modern office buildings. Architect:  
Sidney Eisenshtat.

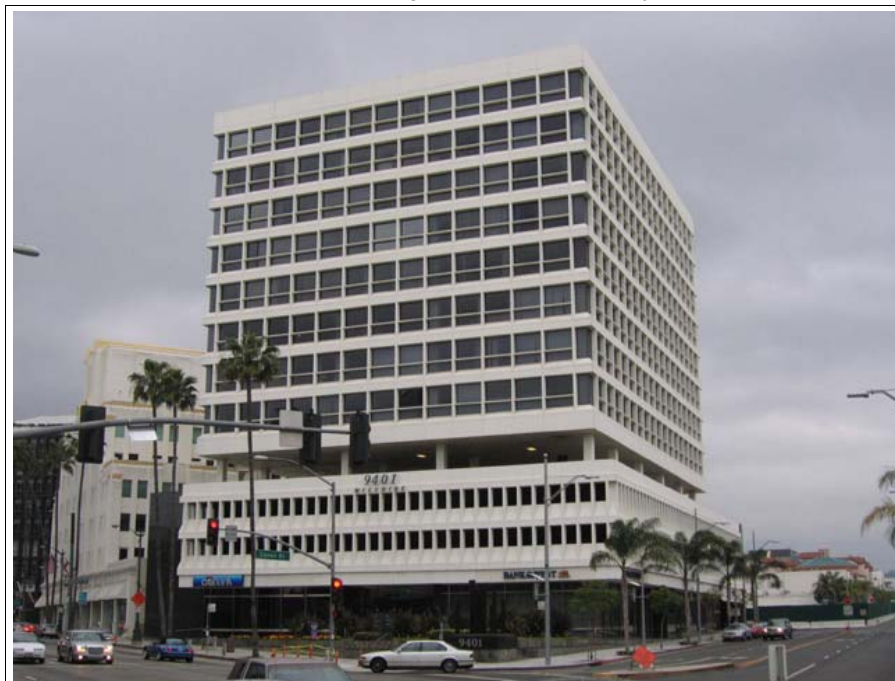
\* P3a. Description: (Describe resource and its major elements. Include design, materials, condition, alterations, size, setting, and boundaries.)  
Contributor to a potential California Register district (Criterion 3) of Post World War II modern office buildings.

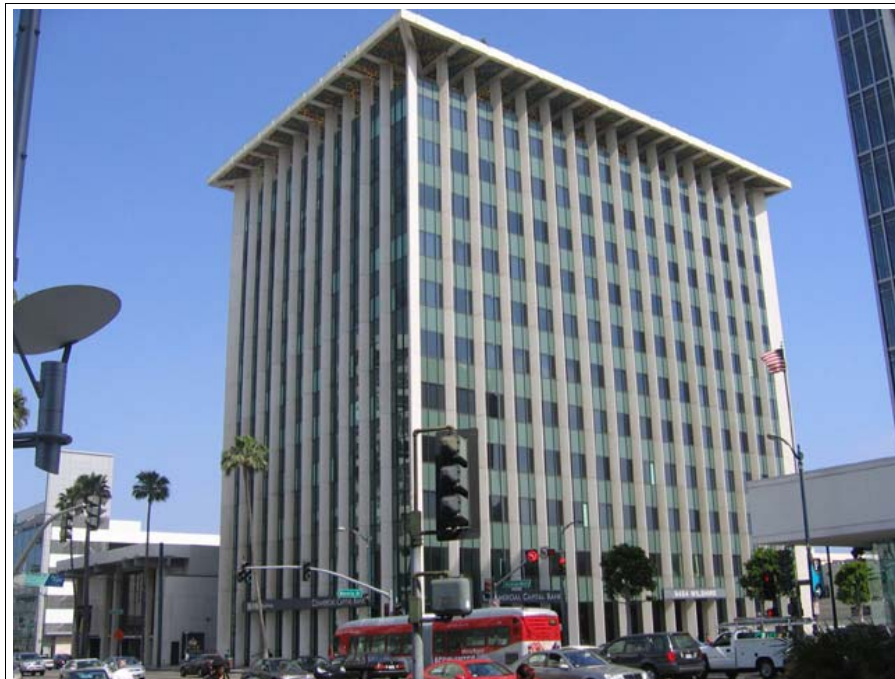
\* P3a. Description: (Describe resource and its major elements. Include design, materials, condition, alterations, size, setting, and boundaries.)  
Contributor to potential California Register district (Criterion 3) of Post World War II modern office buildings. Architect:  
Langdon and Wilson.

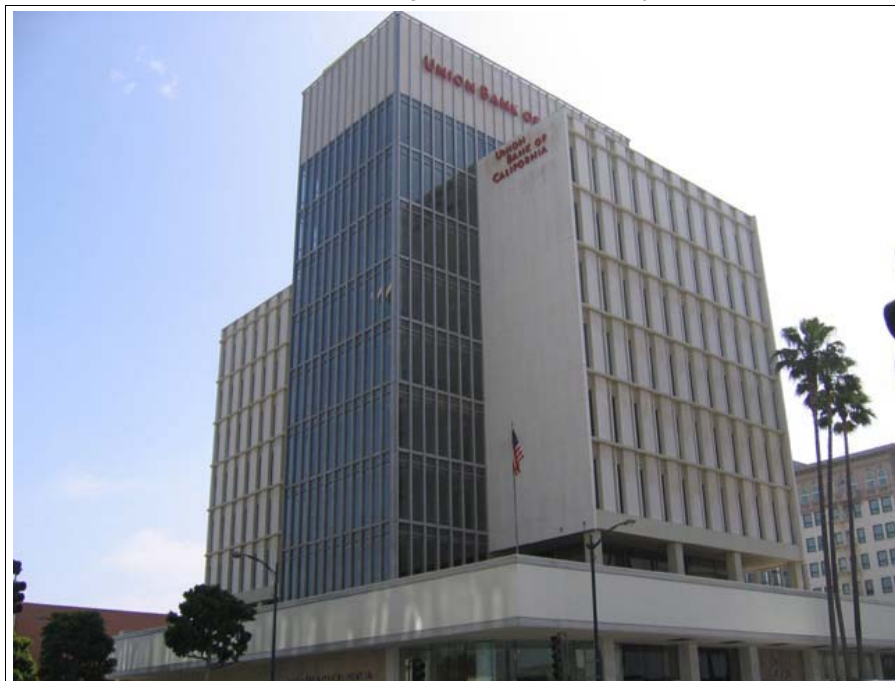
- \* **P3a. Description:** (Describe resource and its major elements. Include design, materials, condition, alterations, size, setting, and boundaries.)  
Contributor to potential California Register district (Criterion 3) of Post World War II modern office buildings. Architect:  
Sidney Eisenshtat.

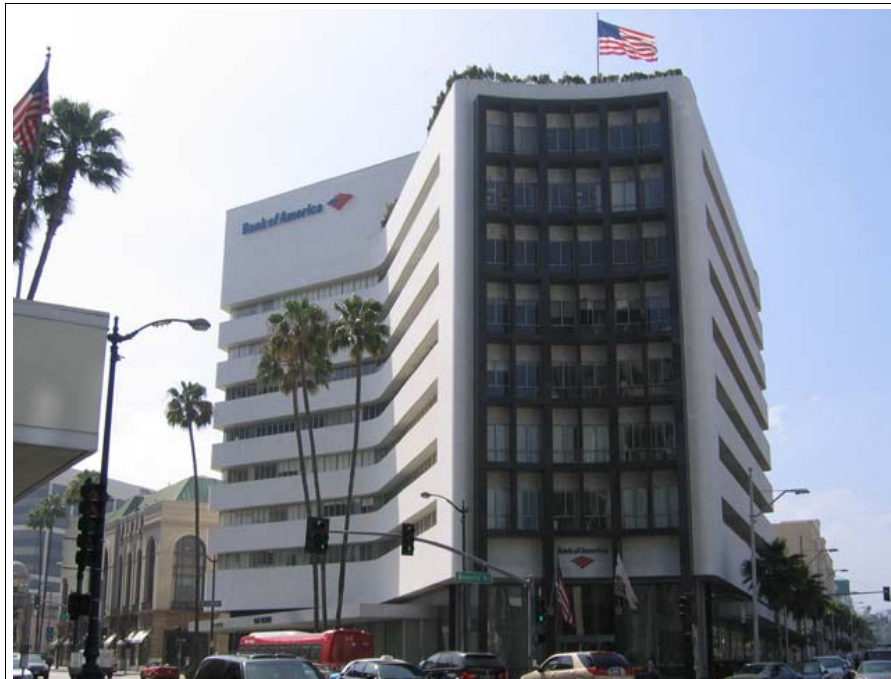
\* P3a. Description: (Describe resource and its major elements. Include design, materials, condition, alterations, size, setting, and boundaries.)  
Contributor to a potential California Register district of (Criterion 3) Post World War II modern office buildings. Architect:  
Victor Gruen Associates.

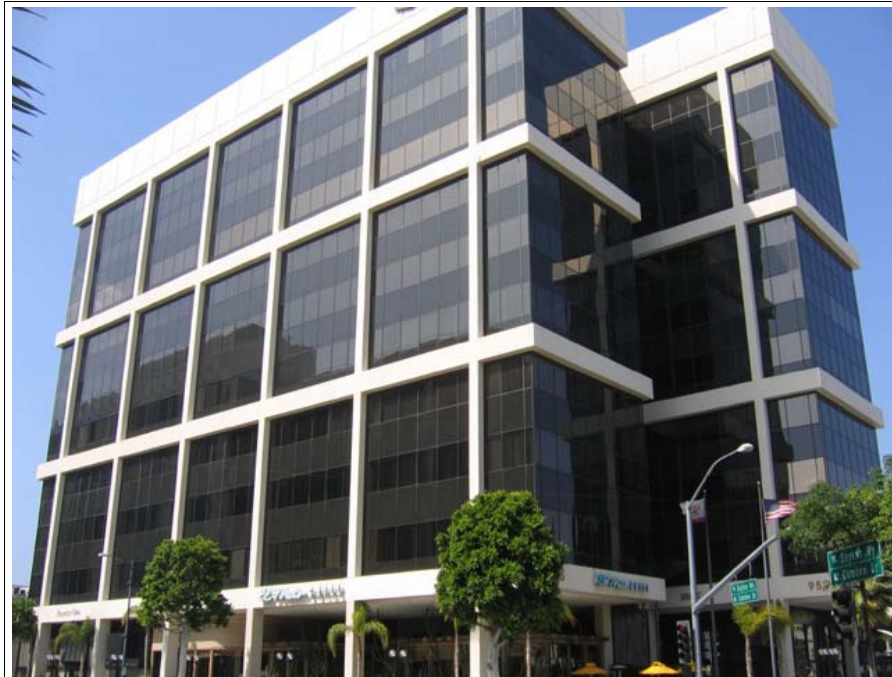
\* P3a. Description: (Describe resource and its major elements. Include design, materials, condition, alterations, size, setting, and boundaries.)  
Contributor to a potential California Register district (Criterion 3) of Post World War II modern office buildings.

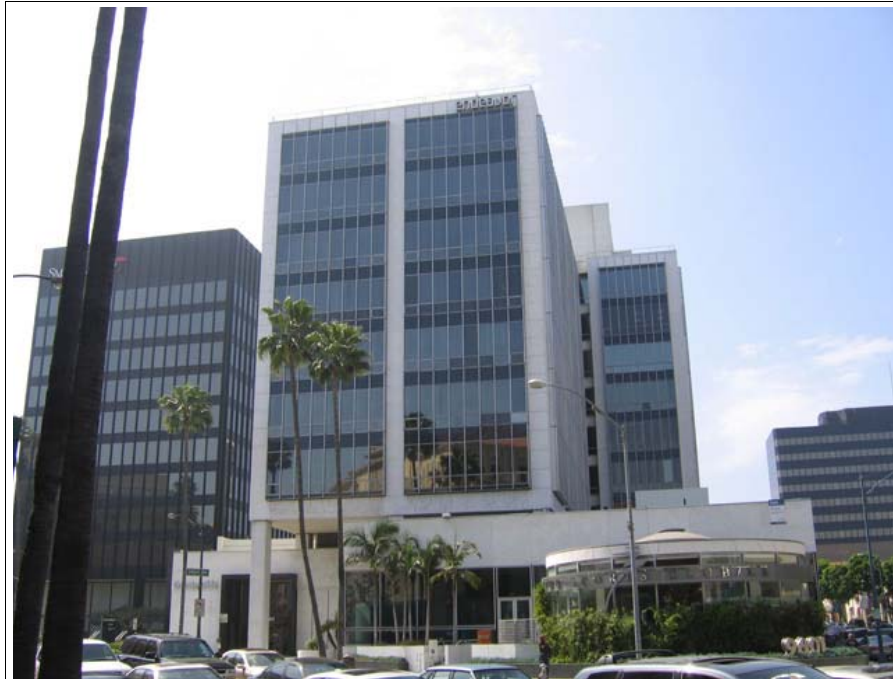
\* P3a. Description: (Describe resource and its major elements. Include design, materials, condition, alterations, size, setting, and boundaries.)  
Contributor to a potential California Register district of (Criterion 3) Post World War II modern office buildings. Architect:  
Charles Luckman and Max Horwitz.

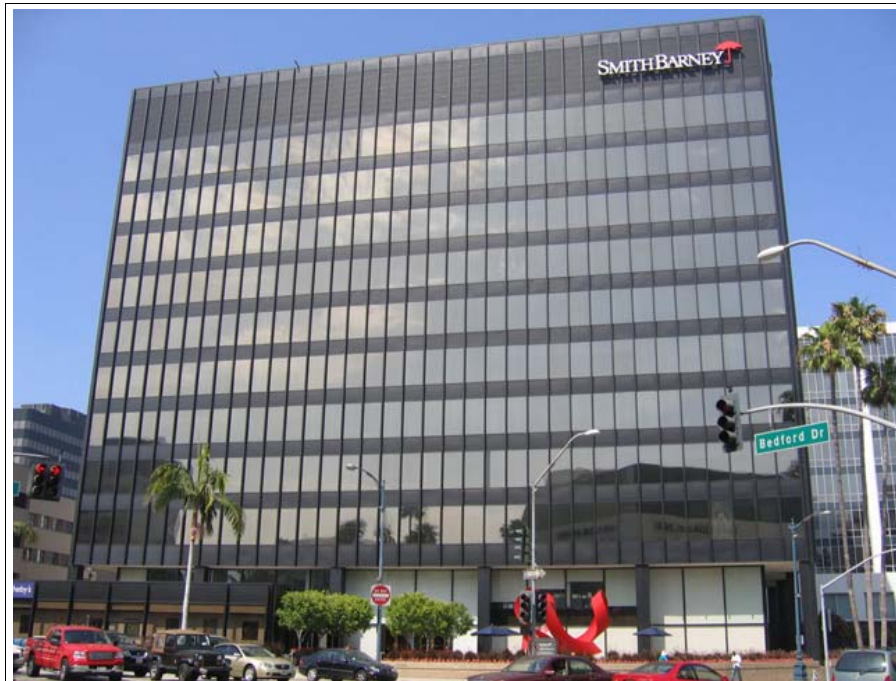
\* P3a. Description: (Describe resource and its major elements. Include design, materials, condition, alterations, size, setting, and boundaries.)  
Contributor to a potential California Register district of (Criterion 3) Post World War II modern office buildings. Architect:  
Craig Elwood.

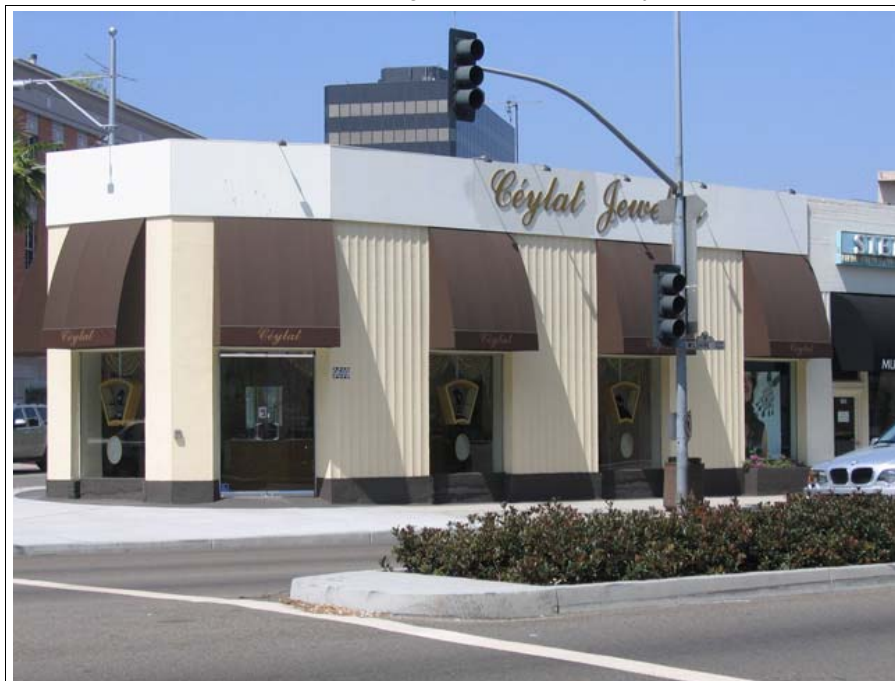
\* P3a. Description: (Describe resource and its major elements. Include design, materials, condition, alterations, size, setting, and boundaries.)  
Contributor to a potential California Register district (Criterion 3) of Art Deco/Moderne buildings.

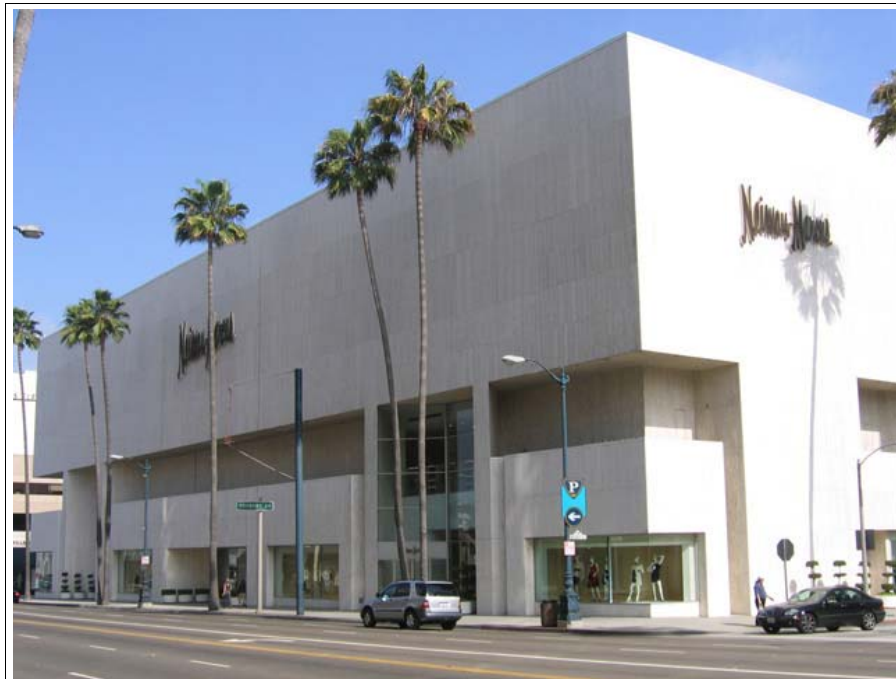
- \* **P3a. Description:** (Describe resource and its major elements. Include design, materials, condition, alterations, size, setting, and boundaries.)  
Appears to be individually eligible for the California Register under Criterion 3, as an important example of the work of a master architect, John Carl Warnecke.

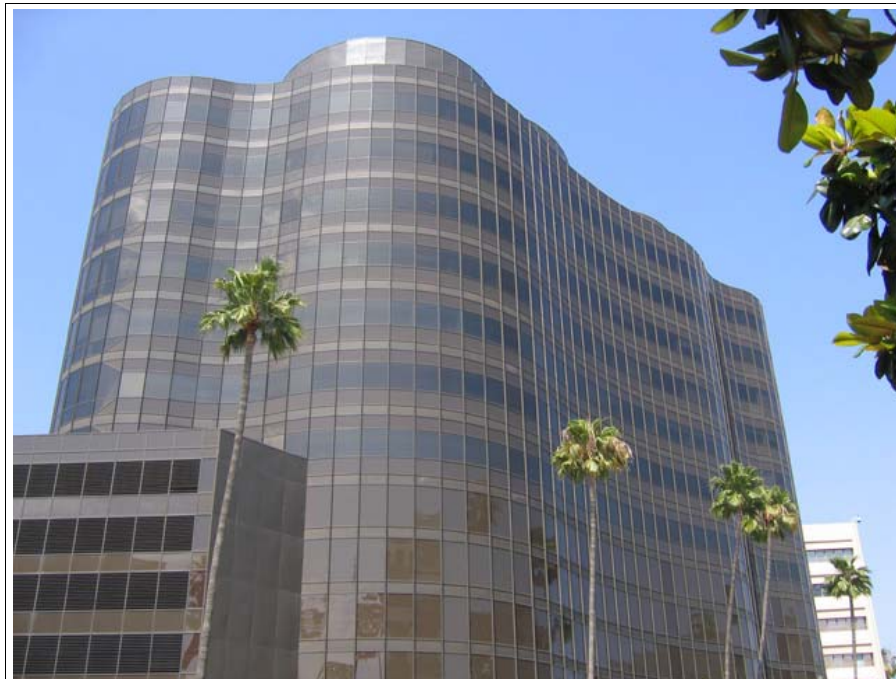
\* P3a. Description: (Describe resource and its major elements. Include design, materials, condition, alterations, size, setting, and boundaries.)  
Contributor to a potential California Register district of (Criterion 3) Post World War II modern office buildings. Also appears to be individually eligible for the National Register under Criterion C, meeting Criteria consideration G, with exceptional significance, as an important, pioneering example of Late Modern architecture by a master architect, Anthony Lumsden, that was widely published internationally.

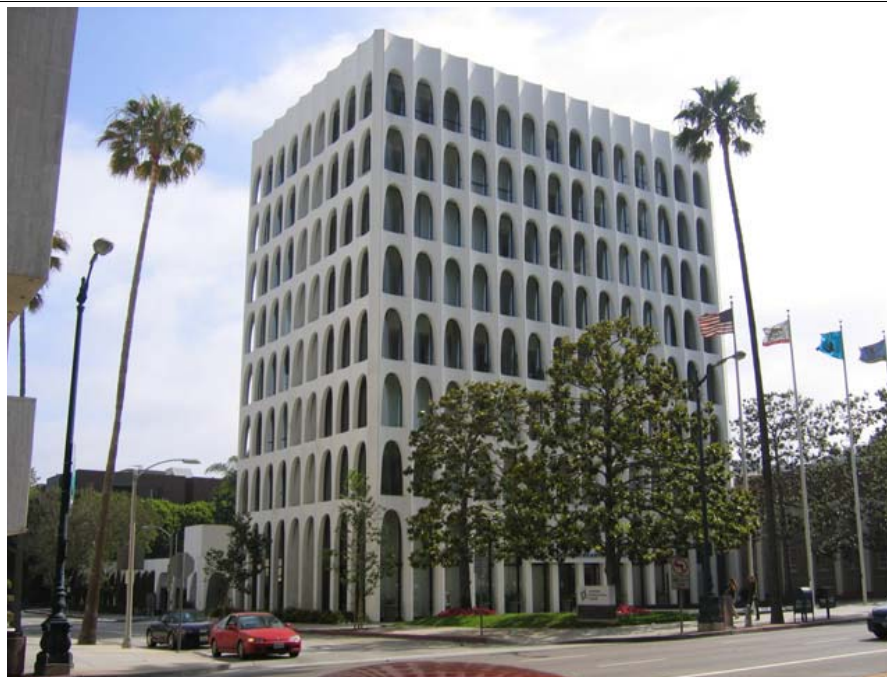
\* P3a. Description: (Describe resource and its major elements. Include design, materials, condition, alterations, size, setting, and boundaries.)  
Appears to be individually eligible for the California Register under Criterion 3, as an important example of the work of a master architect, Edward Durrell Stone, and as a contributor to a potential California Register district of (Criterion 3) Post World War II modern office buildings.

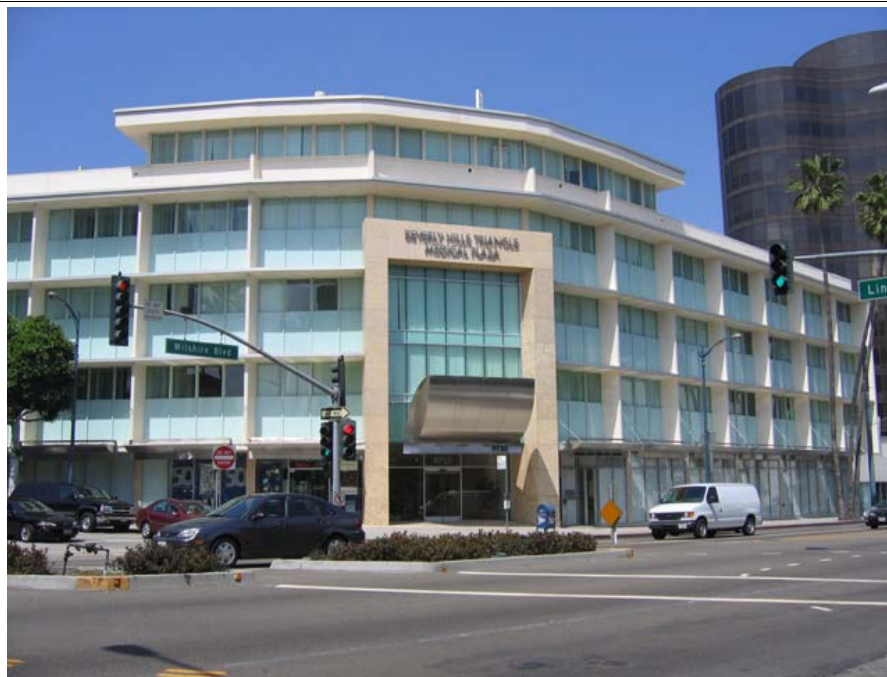
\* P3a. Description: (Describe resource and its major elements. Include design, materials, condition, alterations, size, setting, and boundaries.)  
Contributor to a potential California Register district (Criterion 3) of Post World War II modern office buildings. Architect:  
Herman C. Light.

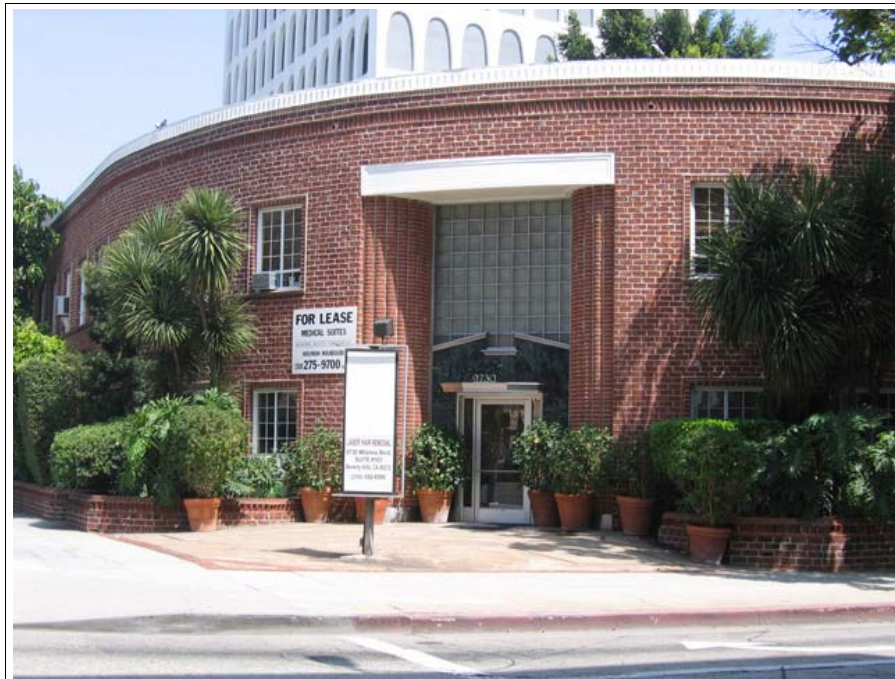
\* P3a. Description: (Describe resource and its major elements. Include design, materials, condition, alterations, size, setting, and boundaries.)  
Contributor to a potential California Register district (Criterion 3) of Regency Revival buildings.

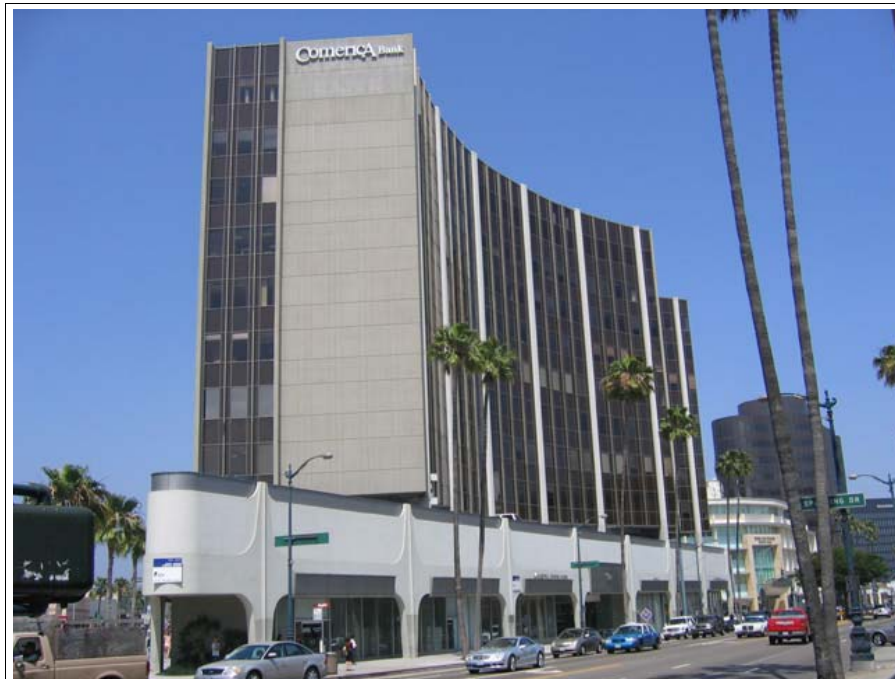
\* P3a. Description: (Describe resource and its major elements. Include design, materials, condition, alterations, size, setting, and boundaries.)  
Contributor to a potential California Register district of (Criterion 3) Post World War II modern office buildings. Architect:  
Sidney Eisenshtat.

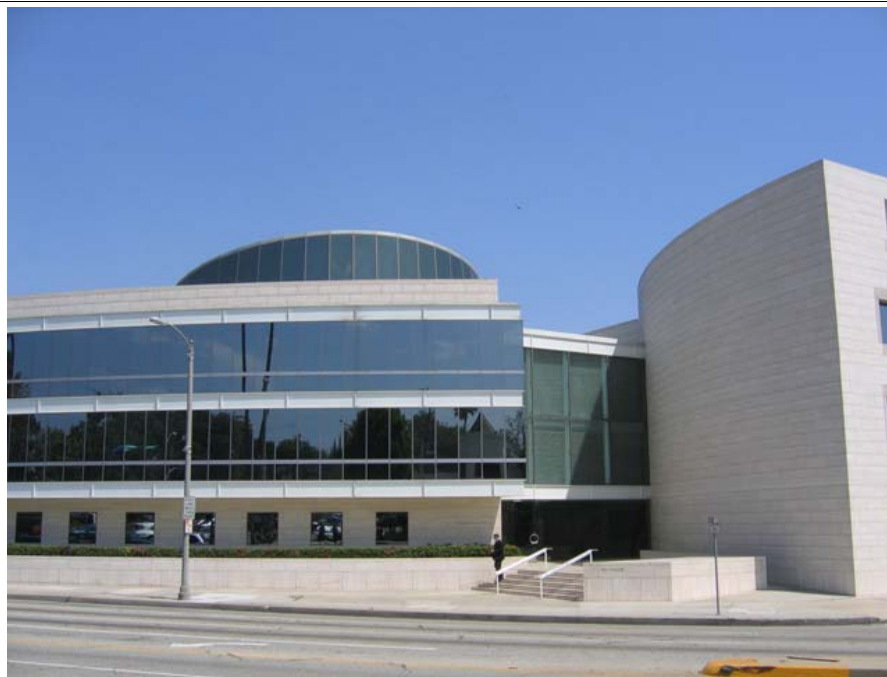
\* P3a. Description: (Describe resource and its major elements. Include design, materials, condition, alterations, size, setting, and boundaries.)  
Appears to be individually eligible for the California Register under Criterion 3, as an important example of the work of a master architect, I.M. Pei.

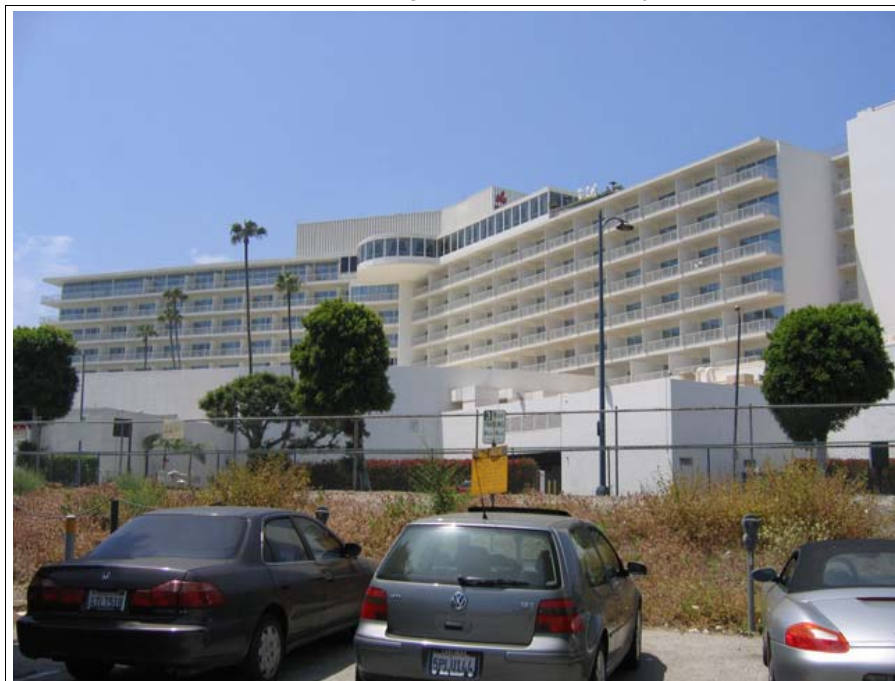
\* P3a. Description: (Describe resource and its major elements. Include design, materials, condition, alterations, size, setting, and boundaries.)  
Appears to be eligible for the National Register under Criteria A, for its association with important events, under Criterion B for its association with Conrad Hilton, and under Criterion C, as an important example of the work of a master architectural firm, Welton Becket and Associates.

Original Owner: Hilton Hotels Corp.  
Architect: Beckett; Welton  
Builder: Webb; Del E. Construction Co.

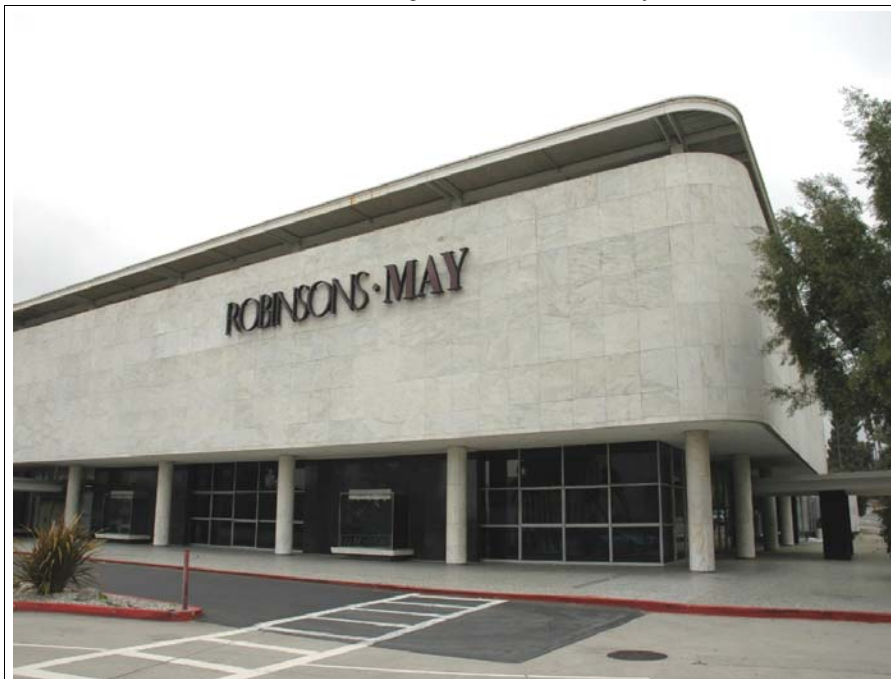
\* P3a. Description: (Describe resource and its major elements. Include design, materials, condition, alterations, size, setting, and boundaries.)  
The J.W. Robinson's Department Store in Beverly Hills opened to the public on February 13, 1952. It was completed at a cost of \$6,000,000, and was designed by the architectural firm of Pereira and Luckman with Charles O. Matcham architect. Renowned industrial designer Raymond Lowey laid out the interior scheme for the three and four level, 238,000 square foot store building.
